Development of Induced Magnetic Field Procedure for Nondestructive Evaluation of
Deteriorated Prestressing Strand

Submitted to the Graduate Faculty as partial fulfillment of the requirements for the
Master of Science Degree in Civil Engineering

The University of Toledo
May 2011

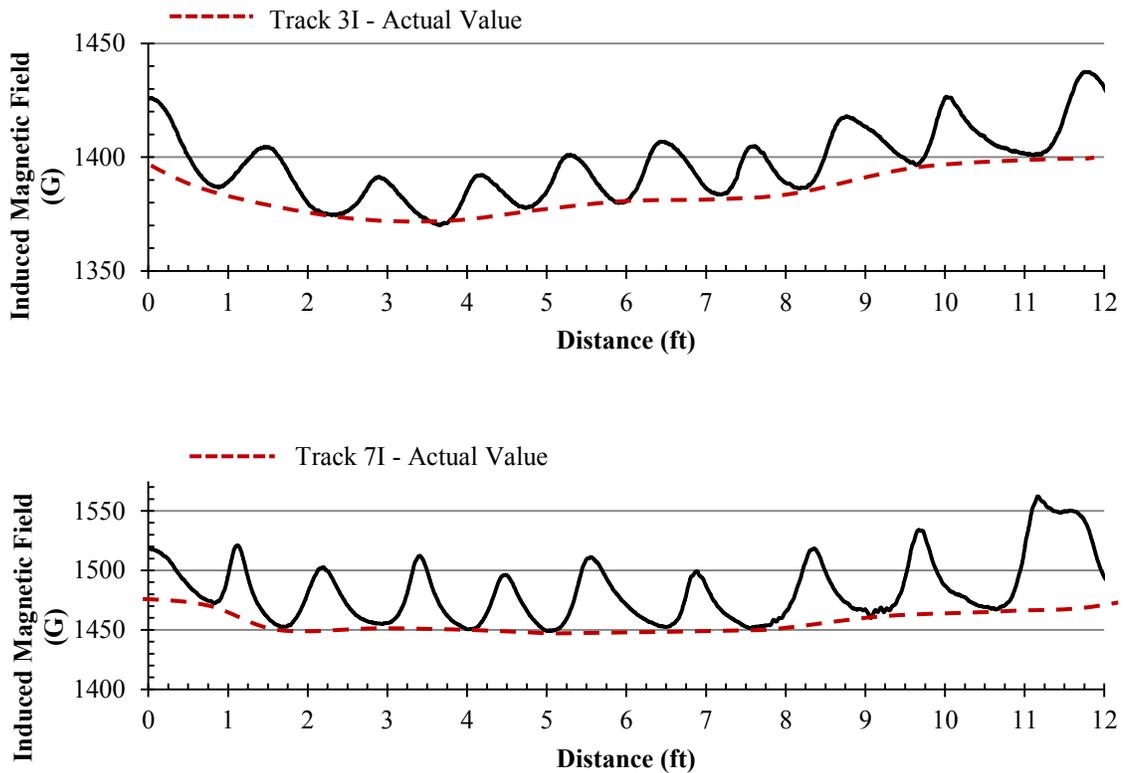
Figure 4-6: IMF scan data for interior beams – Tracks 3I and 7I.

Table 4.1 below shows the percent corrosion for the scans at regular intervals for scan 3I and 7I. The results obtained are based on two assumptions; the ultimate strength of the magnet at the time of the test scan and the actual distance from strand to sensor. These variables can have a large effect on the results obtained from the IMF scans. As previously discussed, the ultimate strength of the magnet can be documented by installing a thermocouple of the electromagnet. For this test, lab experimentation was used to estimate the ultimate magnet strength at the time of the field tests. In order to accurately assess the distance from strand to sensor, a procedure must be developed. That said, the results from the test were not accurate over the entire length of the scan, but they did

indicate corrosion. The results were accurate for the last few feet of the scan. The author believes that over this range, the distance from sensor to strand was 2.2 in., and the strand was farther from the sensor for the rest of the scan (where higher corrosion than actually found was indicated). This hypothesis cannot be verified. Overall, the IMF field test indicated corrosion, but more updated field tests are necessary to determine with confidence the accuracy of the test system.

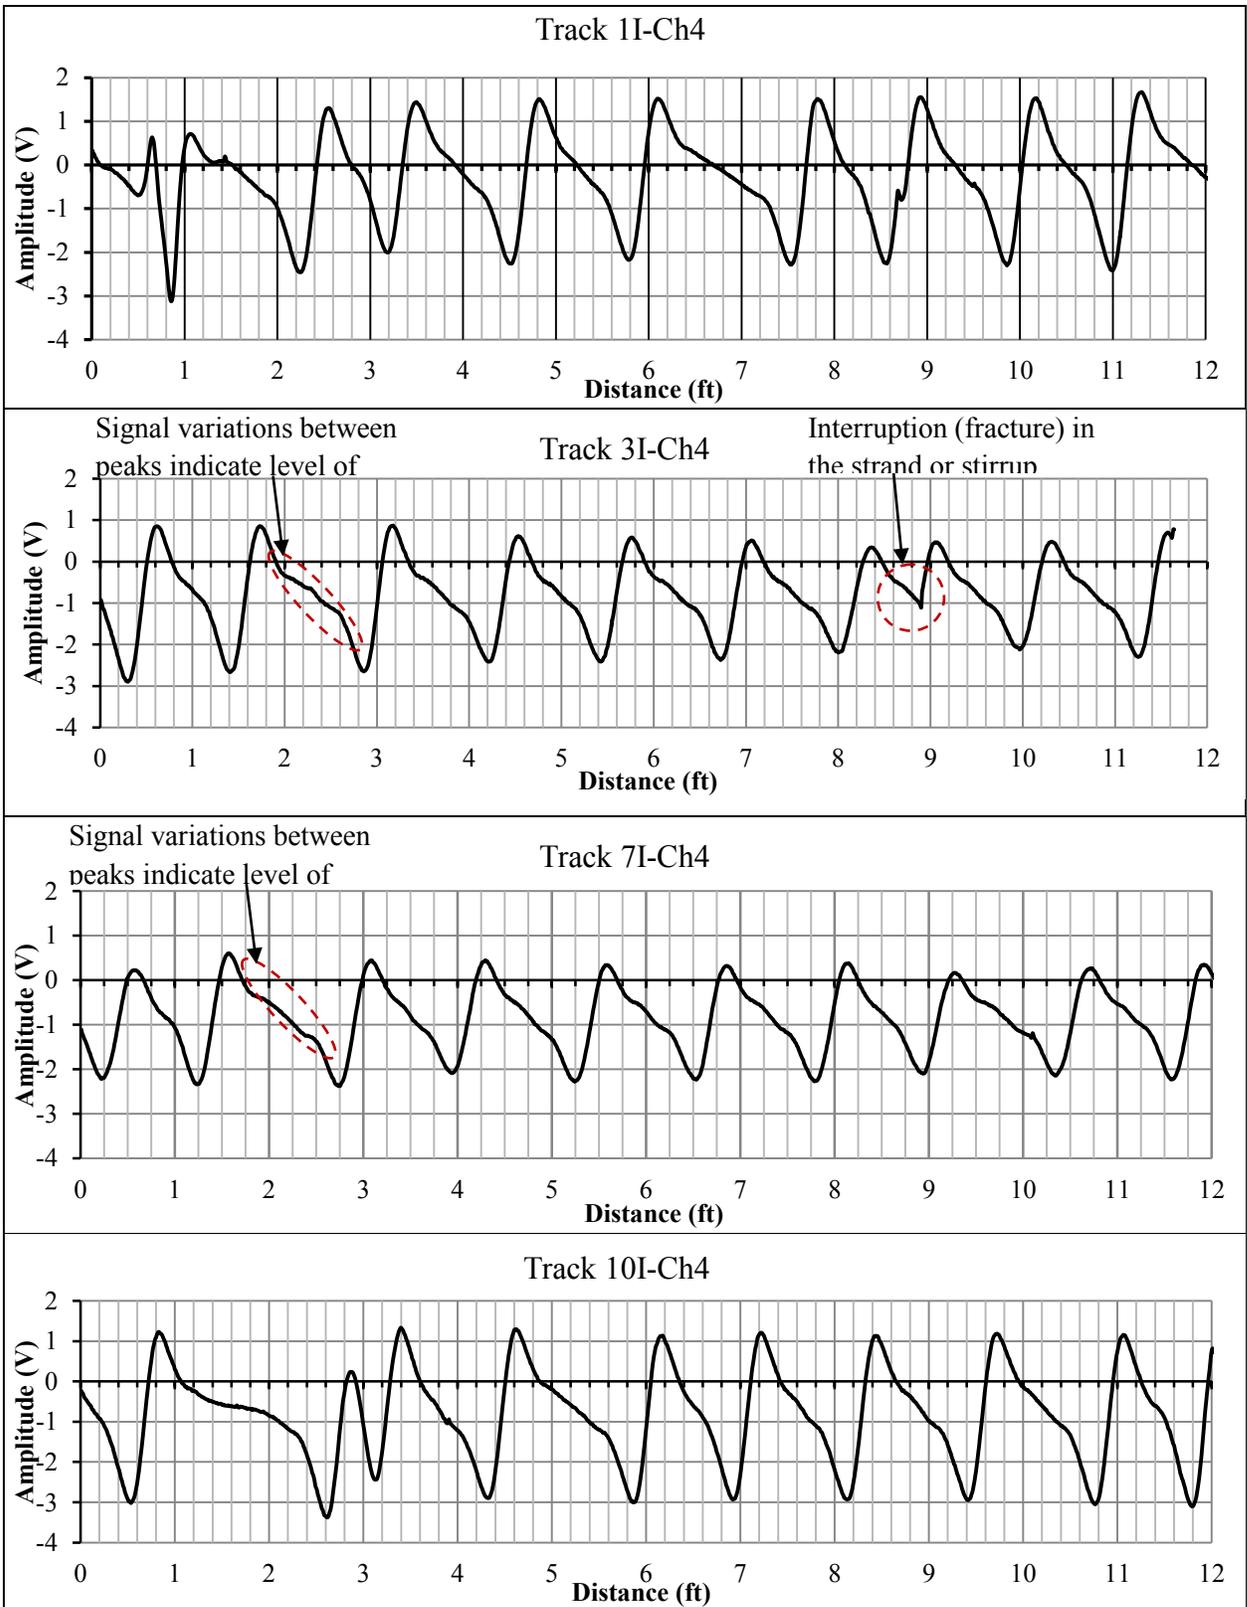
Figure 4-7 shows MFL data for a single sensor (sensor 4 which is located at the center of the scan width) for Tracks 1I, 3I, 7I and 10I in the interior beams. The graph is a plot of magnetic leakage field (in terms of Hall sensor output voltage) as detected along the length of the track scanned. The shape and roughness of the wave form correspond to the characteristics of the strands within the track scanned. The peaks in the graph indicate the presence of transverse stirrups along the beam. The peak-to-peak width of the signal indicates the stirrup spacing in the box-beam. Indications of irregular spacing of stirrups can also be seen for Track 10I in the figure at the beginning of the test scan

(the first 3 ft.). The signal variations between peaks indicate the level of corrosion along the prestressing strand indicated in the figure. The evidence of strand fracture, or abrupt change, at the location of 9 ft. can be seen for Track 3I as an abrupt interruption in the signal. It can also be noted that the decreasing nature of peak-to-peak signal amplitude indicates the increasing depth of steel inside the concrete.

Figure 4-7: MFL scan data for interior beams – Tracks 1I, 3I, 7I and 10I.

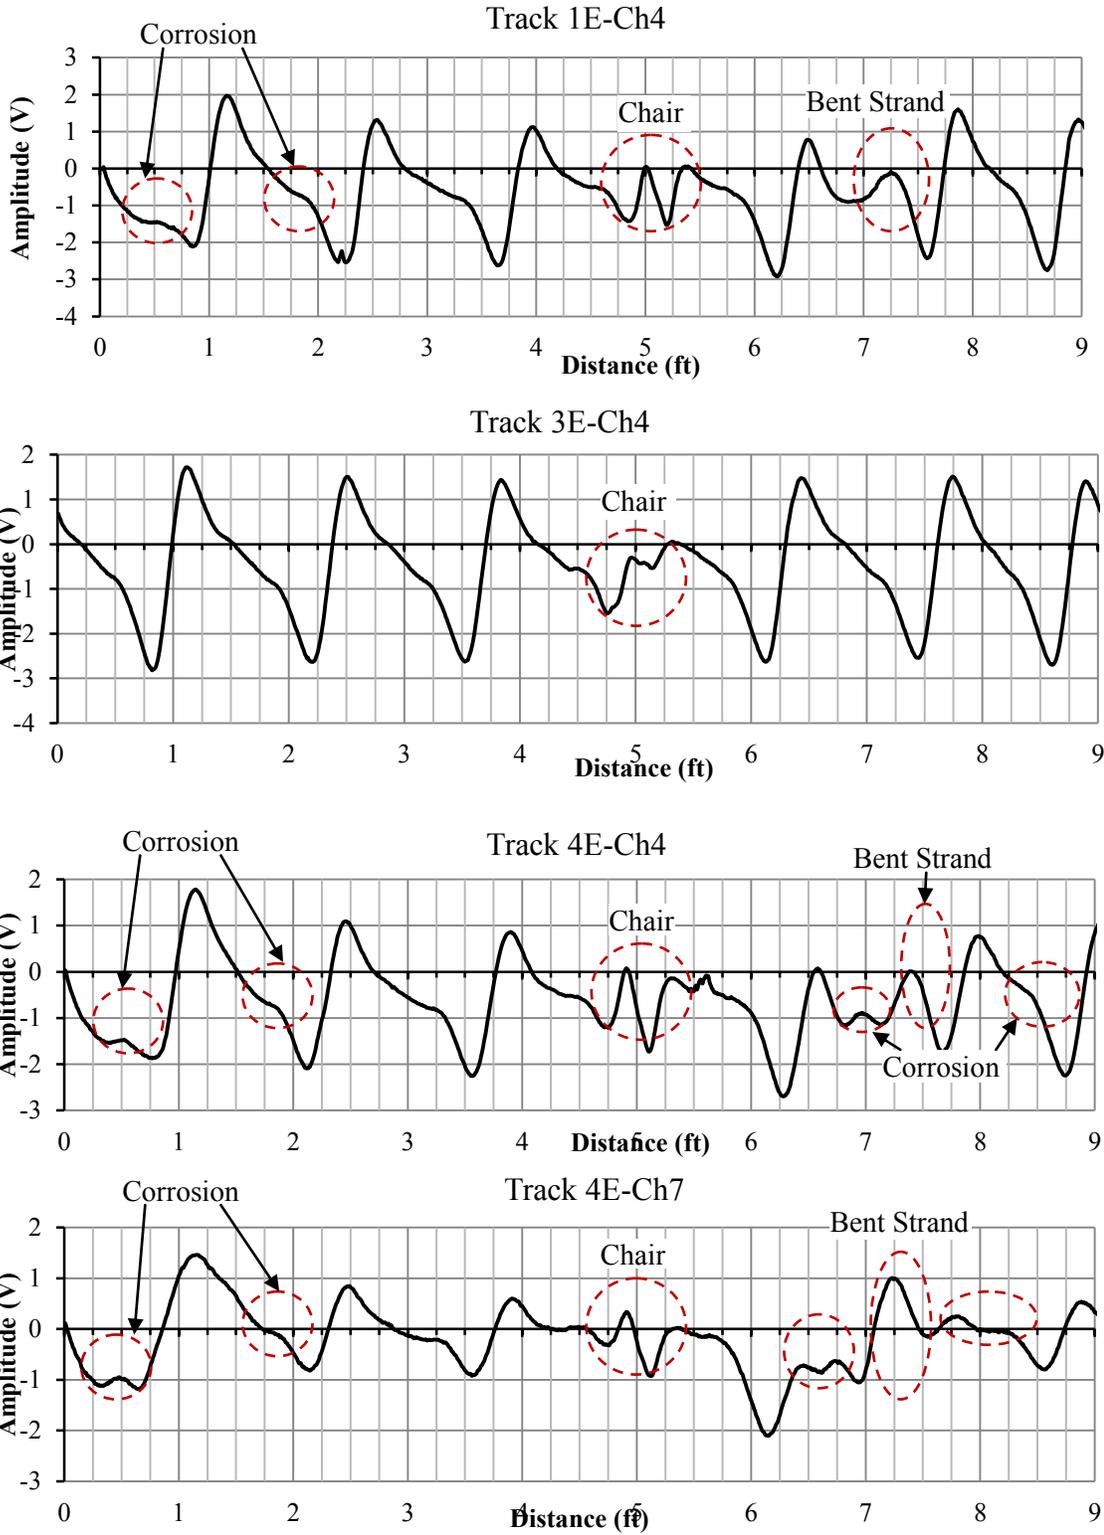
Figure 4-8 shows MFL data for Tracks 1E and 3E from sensor 4 which is located at the center of the scan width. For Track 4E, the data is displayed from sensors 4 and 7 where sensor 7 is located at the north edge (at the outside edge of the beam) of the scan width. Clear indications of the presence of steel chairs as well as exposed and bent strands are shown in the data from different tracks as marked in Figure 4-8. The bumps or bends in the signal between the peaks indicate the presence of chairs at that point inside the box beam. Points of corrosion are indicated by uneven signal amplitude between peaks of the signal. The estimate of corrosion is made by zooming in on the magnetic field signal and making a correlation to the existing laboratory measurements. This method for determining the corrosion is qualitative and provides estimates of corrosion in ranges, (e.g. 10%-15%). While this estimate is not precise, it is sufficient to allow DOT officials to accurately assess the condition of the box beams in a bridge.

Figure 4-8: MFL scan data for exterior beams – Tracks 1E, 3E, and 4E.

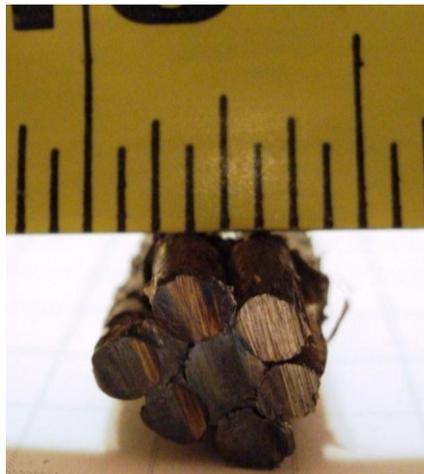
Figure 4-9: Cut strand cross-section (in.) (Track 3I – Dissection Area 2).

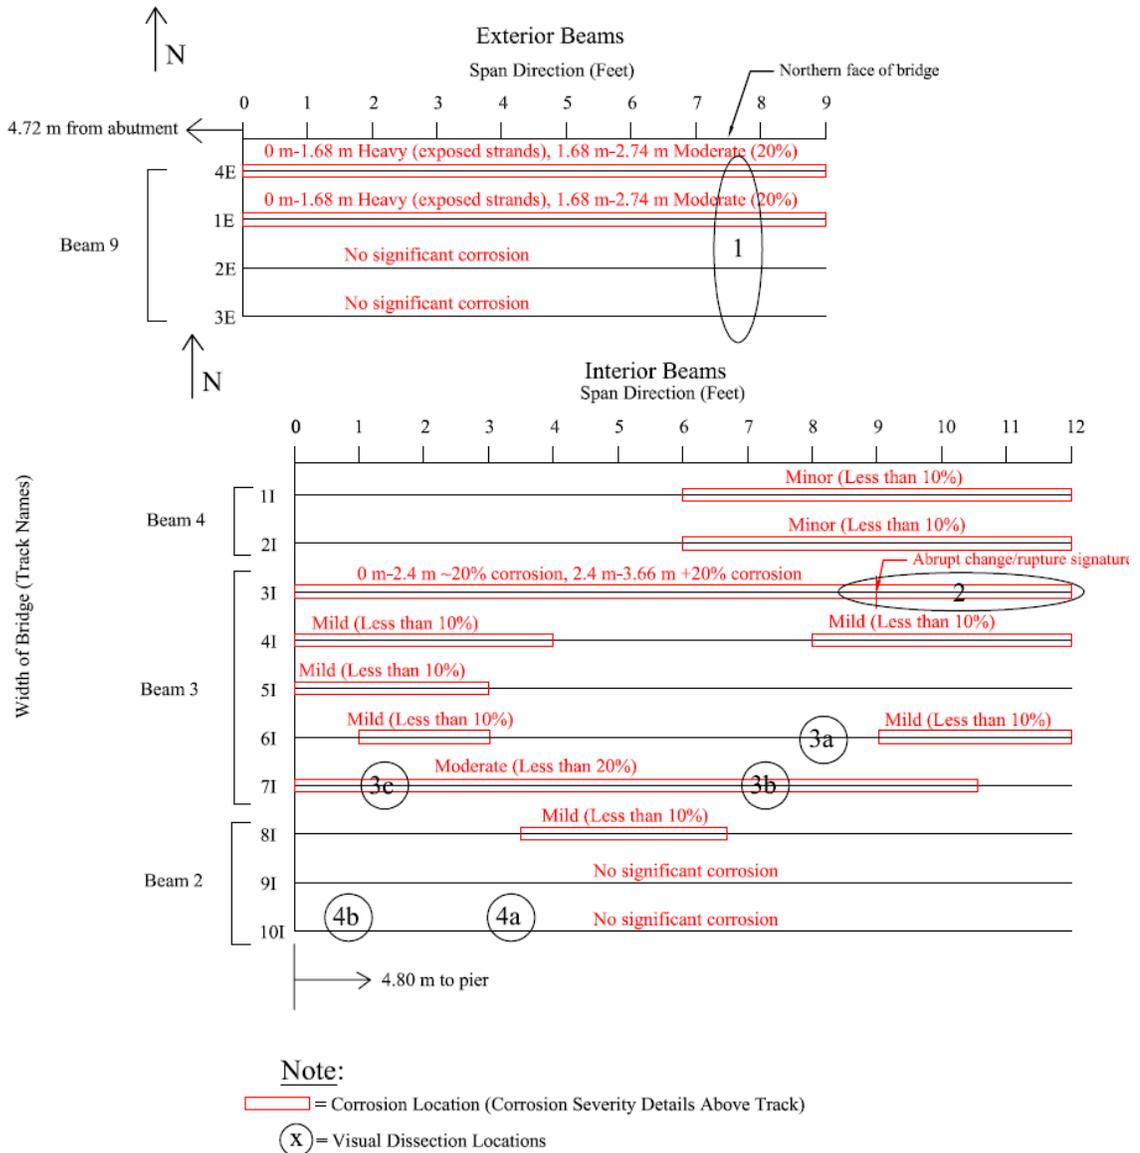
Figure 4-10: Results for corrosion detected for interior and exterior tracks by MFL method – reflected plan.

The results in Table 4.1 for MFL show an accurate correlation between the test results and actual condition of the strand for a majority of the scan tracks. MFL indicated moderate corrosion (20%) in Track 7I, but upon dissection, little corrosion was found in the strands. While the inaccuracy is not desirable it was a false positive, meaning bridge inspectors would be erring conservatively as opposed to the more dangerous situation of not finding corrosion in a damaged strand.

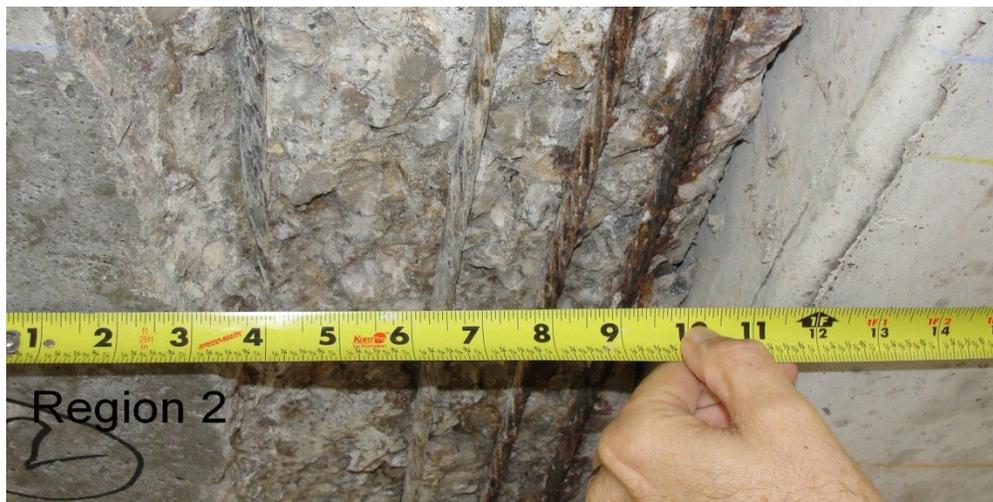
The MFL testing predicted medium to heavy corrosion in dissection area 2 of beam 3, which can be seen in Figure 4-11. The strands from 8 – 10 in., which were completely or partially exposed, show heavy corrosion. The previously embedded strands, from 4 – 7 in., show corrosion that gets progressively lighter as the distance from the joint increases. The magnetic testing was accurate in this region, except that we were unable to find a full break in strands during dissection as depicted in the MFL scan.

Figure 4-11: Dissection results of Area 2 in interior beam 3.

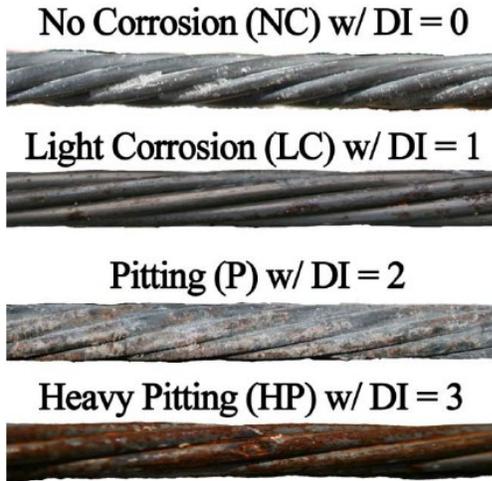
Figure 5-2: Corrosion levels on strand (Naito, et. al, 2010).
