Bio-Engineering for Land Stabilization

Thesis

Presented in Partial Fulfillment of the Requirements for the Degree Master of Science
in the Graduate School of The Ohio State University

Christopher Michael Kokesh, B.S.C.E.

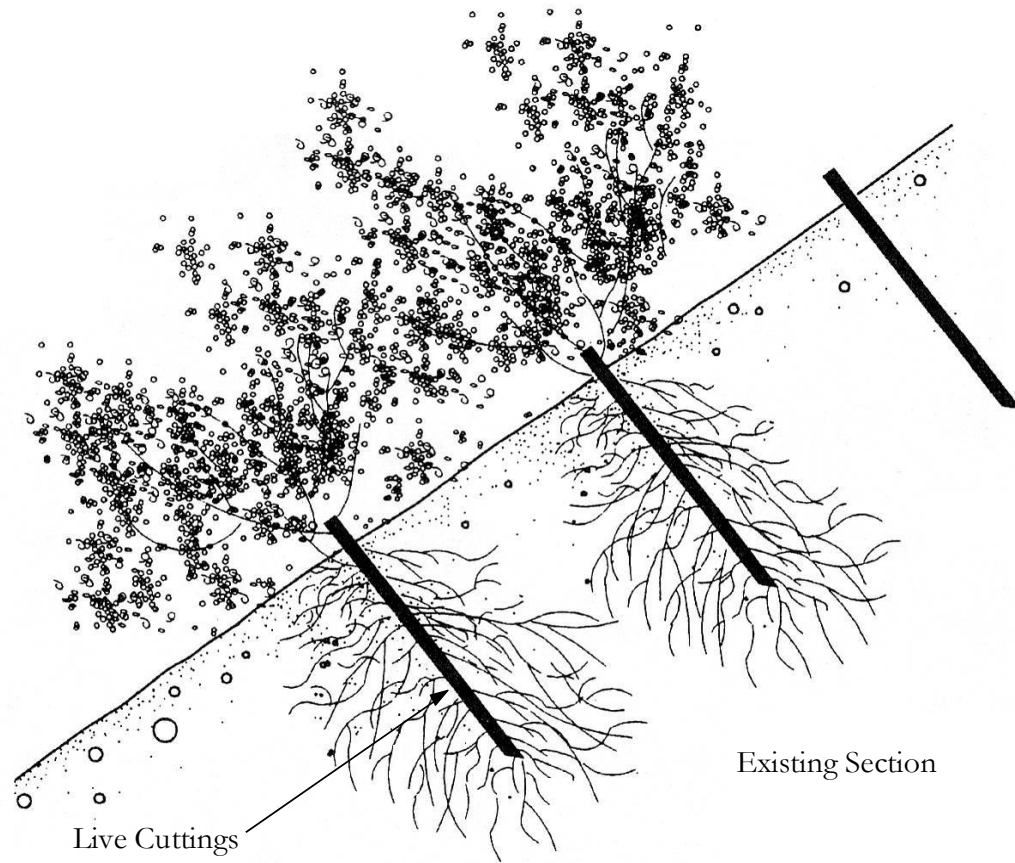
Figure 2.1: Schematic diagram of an established live pole installation. (Gray and Sotir 1996)

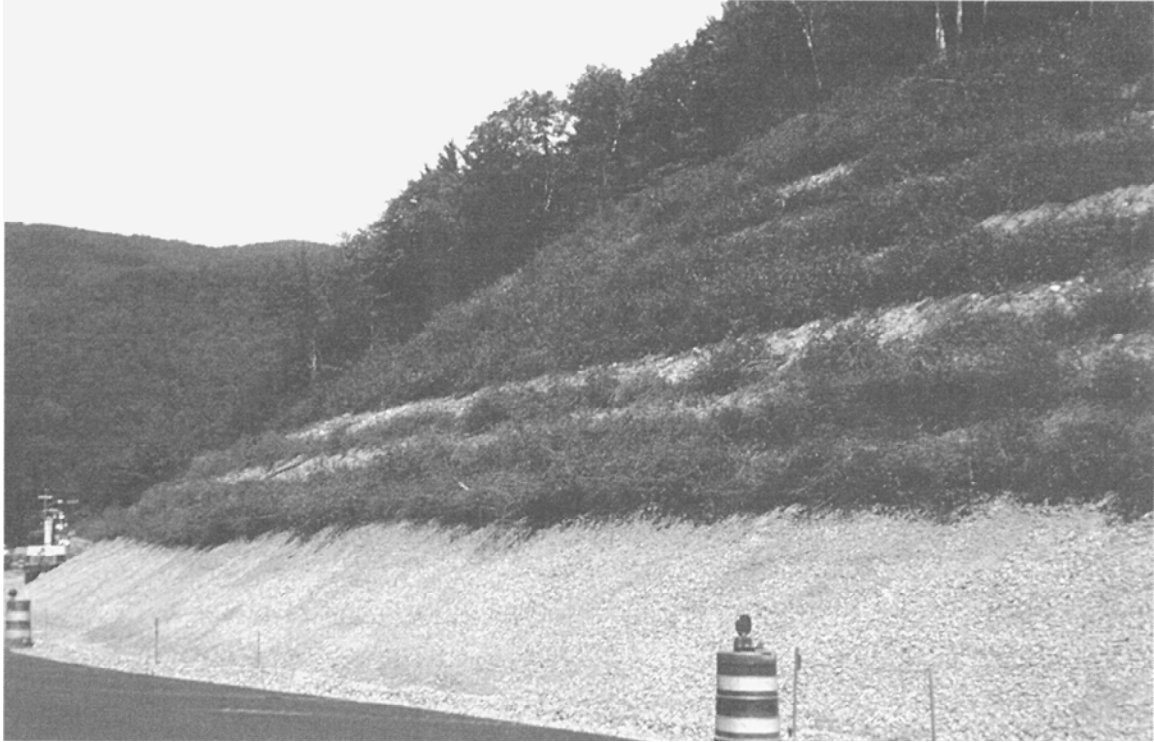
Figure 2.7: Brushlayer fill during first growing season – Greenfield road near the village of Colrain in Massachusetts. Brushlayers have rooted and leafed out. (Gray and Sotir 1996)

To preserve the scenic character, a bioengineering approach was chosen to stabilize a cut slope along Greenfield road near the village of Colrain in Massachusetts in 1989 (Figure 2.7). Road improvements and widening along this road resulted in an unstable cut slope in residual silty sand overlying fractured quartz-mica schist bedrock. The 1.5H:1V unstable cut measured approximately 1,200 ft. in length with heights ranging between 20 to 60 ft. Failures in this slope generally consisted of small slipouts and slumping and, in addition, a substantial amount of groundwater seepage flowing from the cut was observed.

To address the scenic character, global stability, shallow stability, and groundwater seepage, a soil biotechnical solution was applied which consisted of a composite rock toe and earthen brushlayer buttress fill. The stability analyses showed that the rock buttress at the bottom intercepted the critical global failure surface, which passed through the toe of the slope, resulting in an increase in the factor of safety from 1.0 (i.e., failure condition) to 1.5 as calculated by the simplified bishop method (Gray and Sotir 1996).

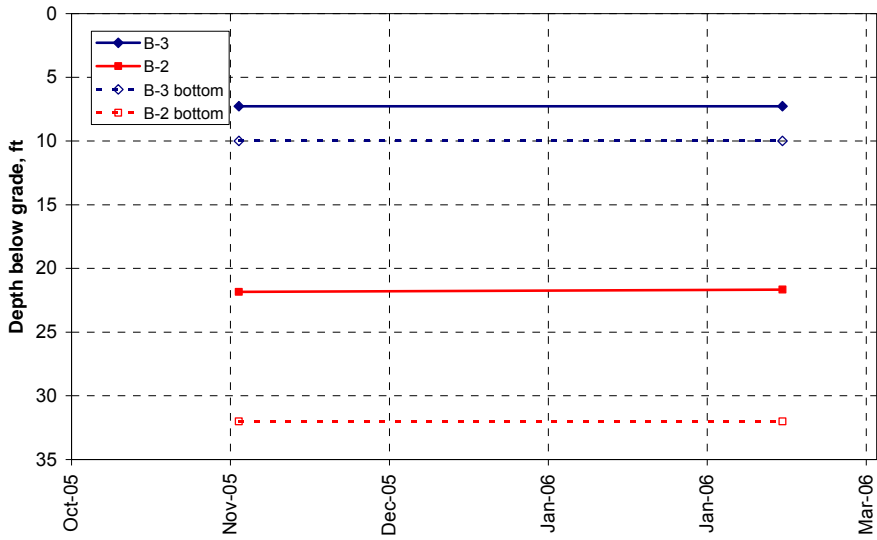
Figure 5.24: Piezometer data for B-1 and B-2.

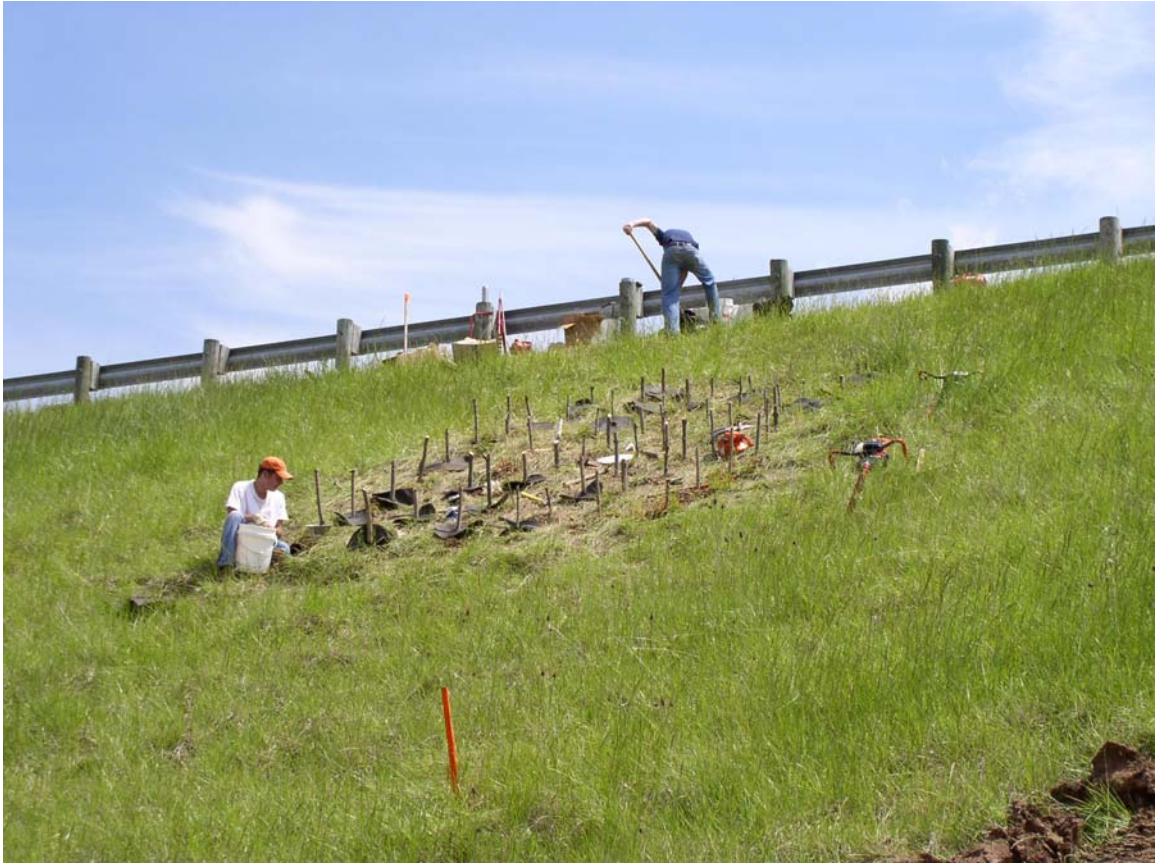
Figure 5.31: Muskingum County upper live pole plot during installation near STA 1+00 (June 2005). (see Figure 5.7 for STA reference)

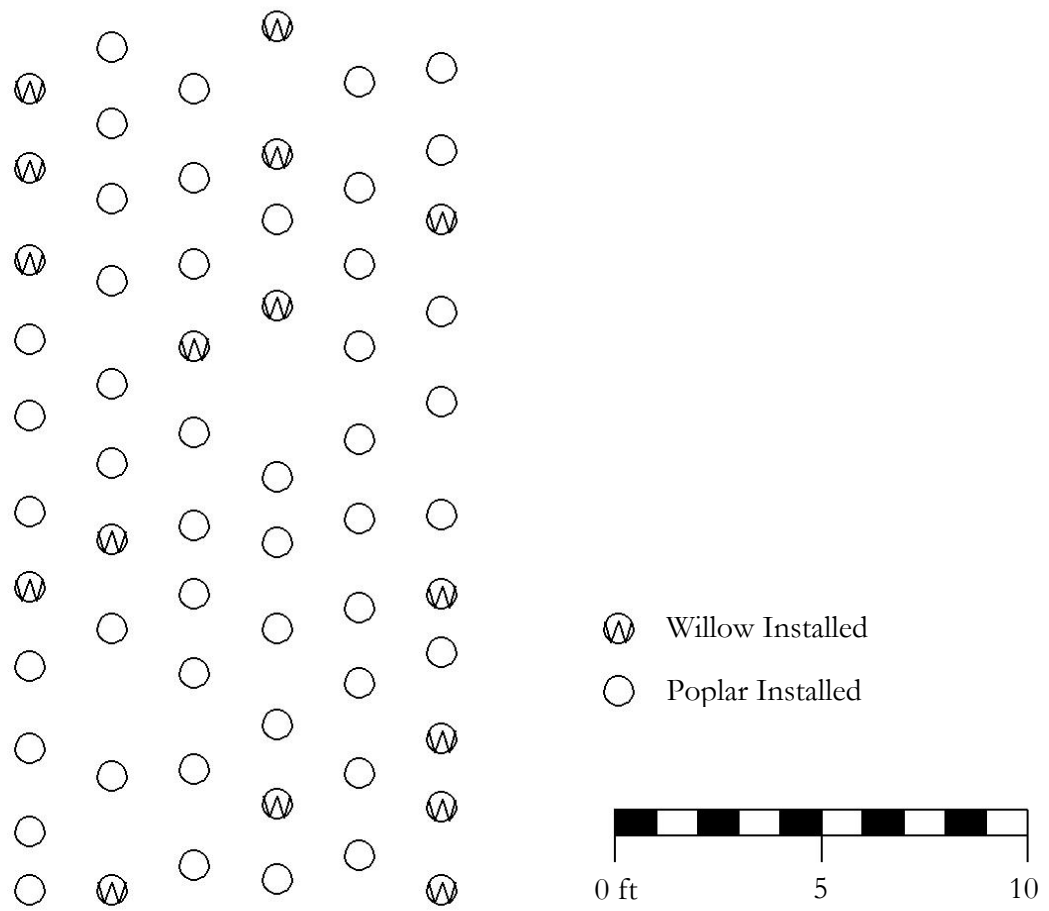
Figure 5.32: Muskingum County upper live pole installation layout.

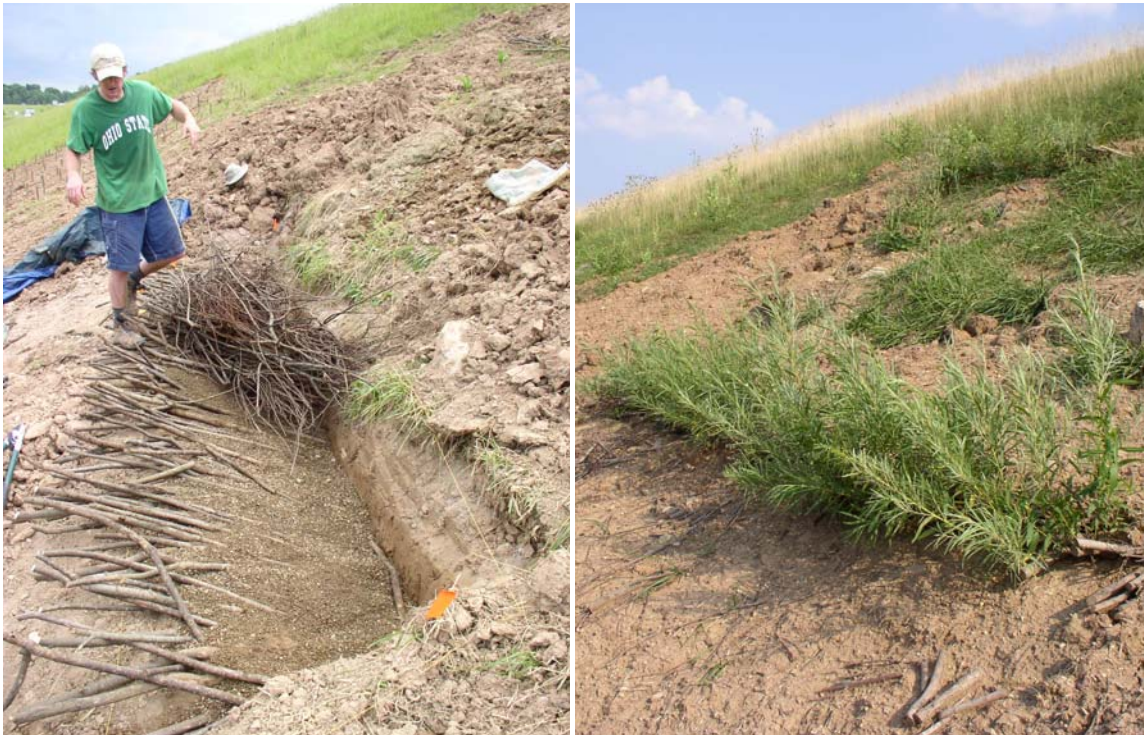
Figure 5.33: Muskingum County brushlayer installation: Left: Brushlayer construction (6/15/05); Right: Established brushlayer (8/2/05).

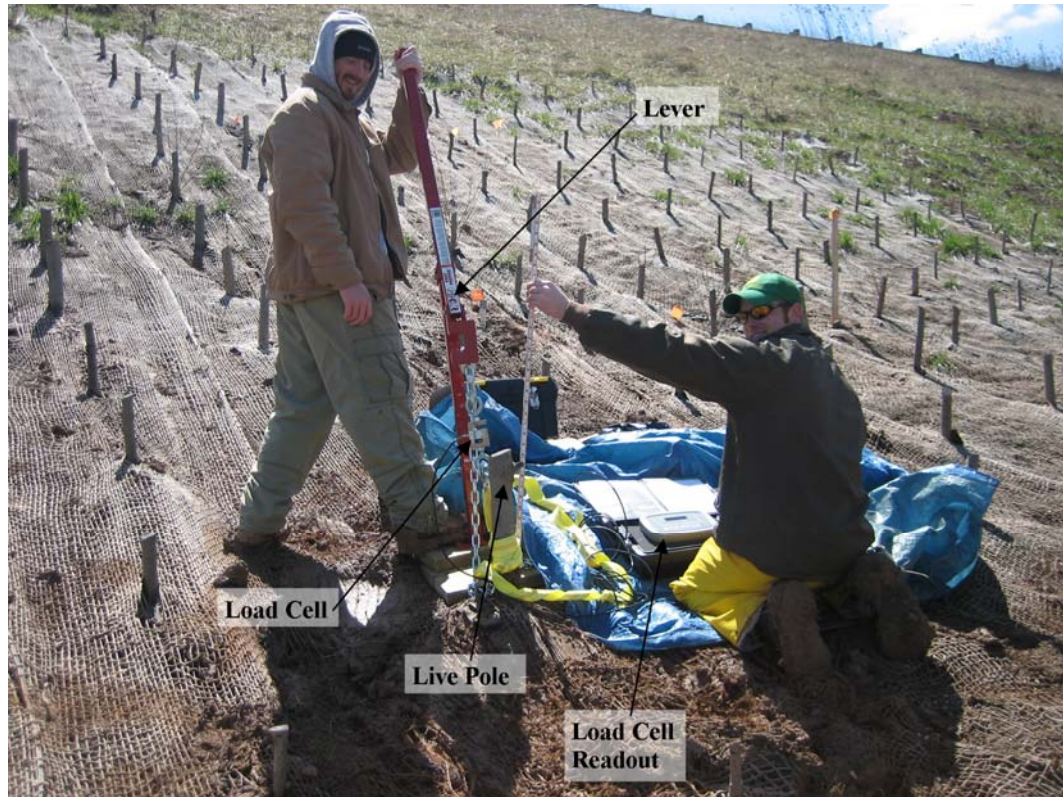
Figure 5.36: Live pole vertical pullout test (April 2006).
