Master of Architecture

The Building Skin | Recladding as Renovation

2010

Christopher J Tomlan

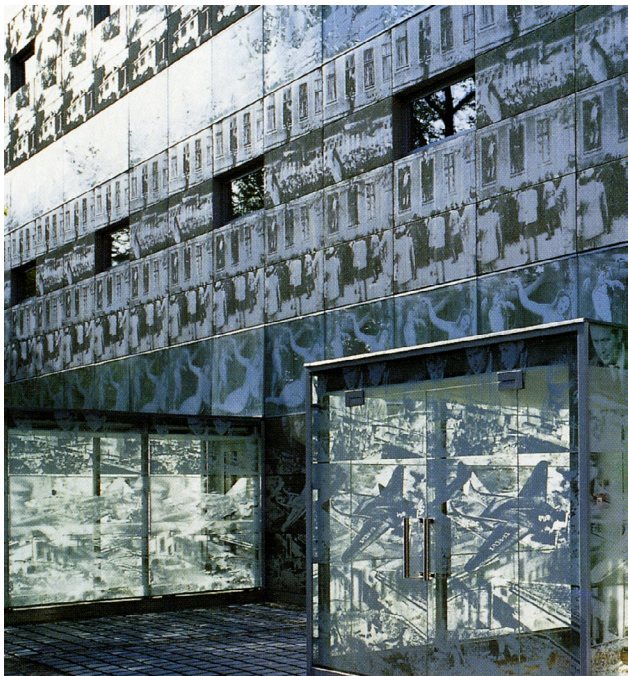
oscillating field of perception. Architecture offers a way of thinking that should offer many incentives for becoming aware of oneself and the world. Their views are expressed in their project, the Library of Eberswalde Academy, built in 1999 (see figure 1.4 for graphic communication through the skin). The exploration of material and surface is one of the principal themes in their works (see figure 1.5 for investigative materials uses).¹⁷ In many of their works, Herzog & de Meuron include an artist or photographer. In a few examples, photographer Thomas Ruff selected the motifs of photos to include in the project. Their work is often intended to tell a story and transform the façade into a projection screen.¹⁸

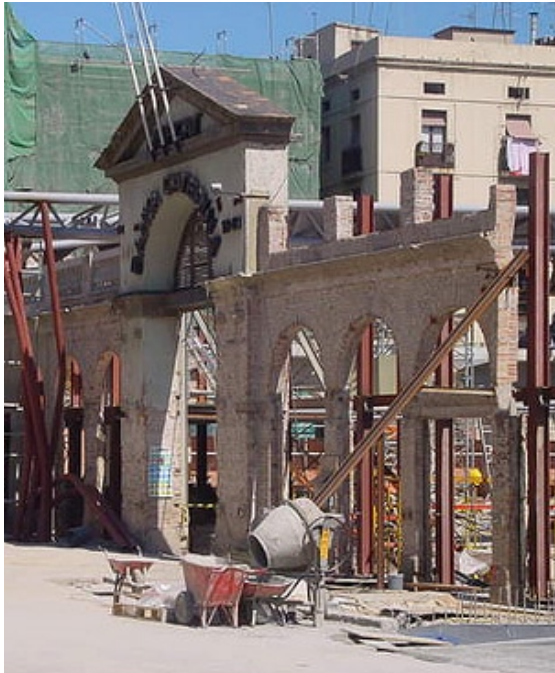
figure 4.10

The renovation of the Santa Caterina Market is intended to provide a safe, public space in one of the worst slums in Barcelona's Gothic Quarter. Within the urban context of the Avenue Cambó area, the project is located near a number of well-designed tourist attractions. The Picasso Museum and Ramblas are just a couple of the attractions that occupy the surrounding context. Due to its proximity with these other significant buildings, the project had an agenda that involved an end result that could serve as a strong identity and recognition for the commercial spaces and market it supports.

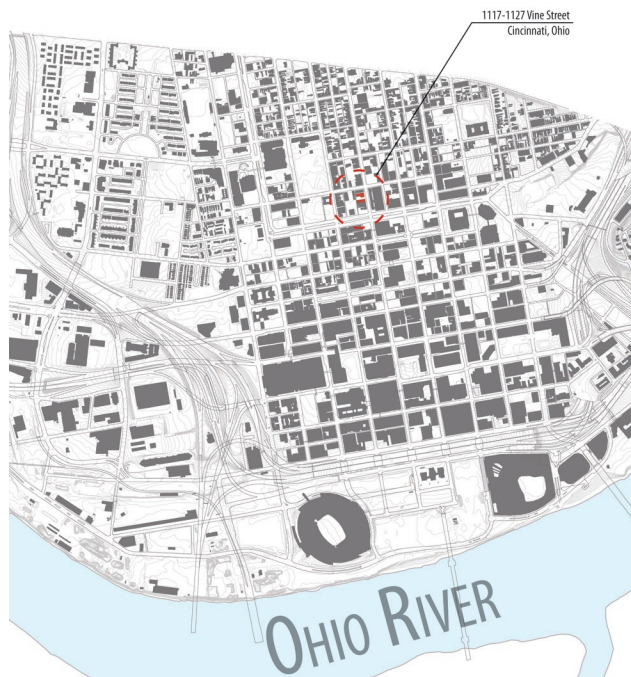
figure 5.0

The site chosen for the thesis project is in Over the Rhine, a neighborhood in Cincinnati that is experiencing less than optimal development (see figures 5.0 & 5.1 for context information). Over the Rhine has been victimized in two ways that have resulted in destruction of historic fabric. The first is a direct result of neglect. Buildings were sealed and boarded up; they were vandalized, inhabited by squatters, or left open to the elements. The second comes under the guise of non-profit organizations intending to improve the community conditions through rebuilding. The neighborhood is prime for complete revitalization, often resulting in demolition (see figures 5.2-5.5 for graphic statistics).¹

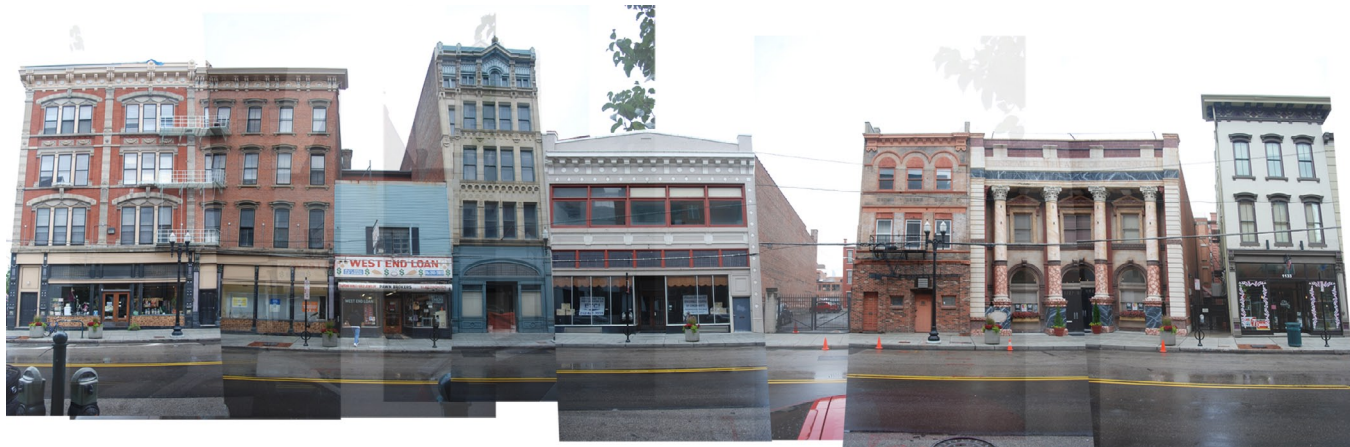
too cold make up 66% of the year. In climate region 3, the average amount of daylight hours is roughly 55%. Heating degree-days total 5,650 and cooling degree-days total 988.⁶ The thesis site on Vine Street is subject to the aforementioned conditions (see figure 5.6 for site photo).

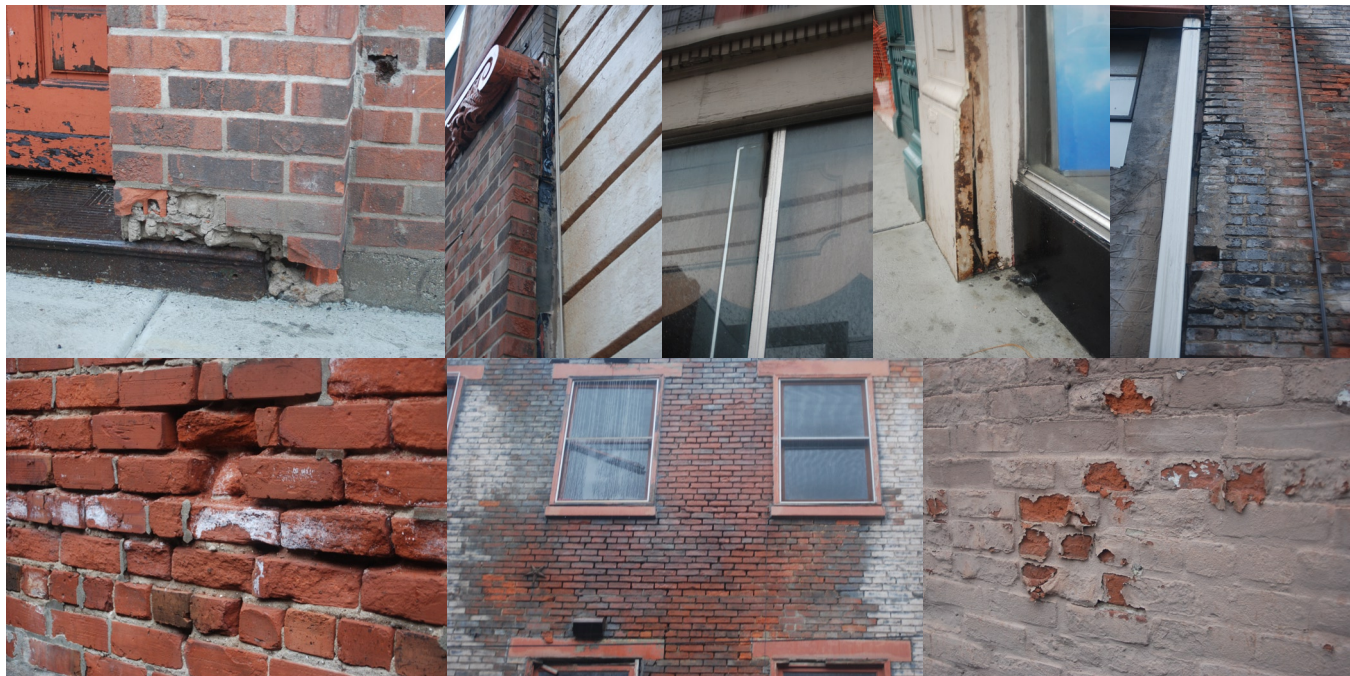
A driving force for the reclad is the deteriorating material of the existing buildings. As mentioned previously, these deteriorating buildings that the thesis targets are often unable to accommodate their modern needs and users. They are characterized by having poor performance and efficiency as well as a low level of aesthetic quality (see figure 5.8 for deteriorations). To fully understand the needs for the chosen thesis site, 1117-1127 Vine Street, a building conditions assessment had to be completed.

The building conditions assessment is intended to evaluate the maintenance condition and serviceability of operating real estate. Building conditions assessments are typically utilized to assess the current conditions and to understand the scope of renovation and resources that will

be required to return the structure to the intended condition. These assessments often include visual inspections of the building, written and photographic documentation of each component of the building, review of general documentation, cursory review of drawings of the building and site, as well as interviews and discussion with on-site personnel. They are in accordance with ASTM standards so that a similar level of detail and investigation can be conducted throughout many buildings.¹²

2. Document exterior and interior of the facade
 3. Identify the structure of the wall (load-bearing, curtain wall, etc.)
 4. Analyze individual components of façade (foundation, brick, cornice, etc.)
 5. Detail how façade terminates (ground, sky, turn the corner)
 6. Assess each opening in the façade (doors & windows)
 7. Make note of any deterioration or decay in façade (document with sketches & photos)
 8. Evaluate and suggest recommendations of each decrepit condition
- Through this investigation, the design process will be aided.

The particular areas of deficiency will be considered and resolved in the recladding solution.
