Novel Environmental Barrier Coatings for Resistance Against Degradation by Molten

Glassy Deposits in the Presence of Water Vapor

THESIS

Caitlin Maureen Toohey

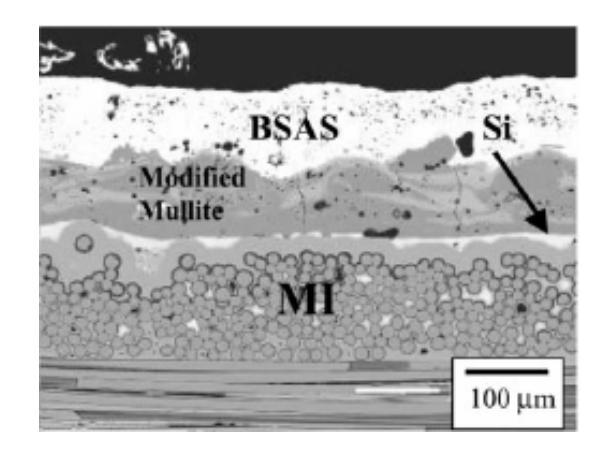
Figure 1: Cross-sectional SEM image of common EBC layering system containing $\ensuremath{\mathsf{BSAS}}^1$

EBCs are a multilayered coating system, used to prevent oxidation of underlying ceramic-matrix composite (CMC) structural components in aircraft gas-turbine engines. A conventional layered system includes an initial layer of dense Si on the CMC, providing a close CTE match. This is followed by a layer that consists of a mixture of mullite and $Ba_{(1-x)}Sr_xAl_2Si_2O_8$ (BSAS),to help prevent oxidation. Often, the dense topcoat consists of BSAS to help increase oxidation resistance and slow SiO₂ volatilization. A cross-sectional SEM image of a representative layering structure is presented in Figure 1.

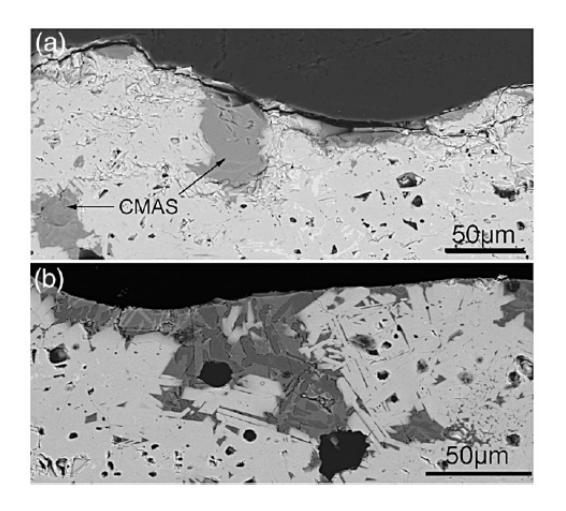
Figure 2: BSE images of reaction between BSAS and CMAS at 1300°C after (a) 1 hour and (b) 4 $\rm hours^2$

This BSAS layered system works well, to a degree. It is challenged by increasing jet engine operating temperatures and environmental demands. Of particular interest is the reaction between BSAS and CMAS when these operating temperatures provide an environment conducive to creating glassy CMAS deposits on the hot section components. CMAS reacts with the BSAS and penetrates the coating. This reaction product increases SiO₂ volatility of the EBC system. Backscattered electron (BSE) images of this reaction can be seen in Figure 2.

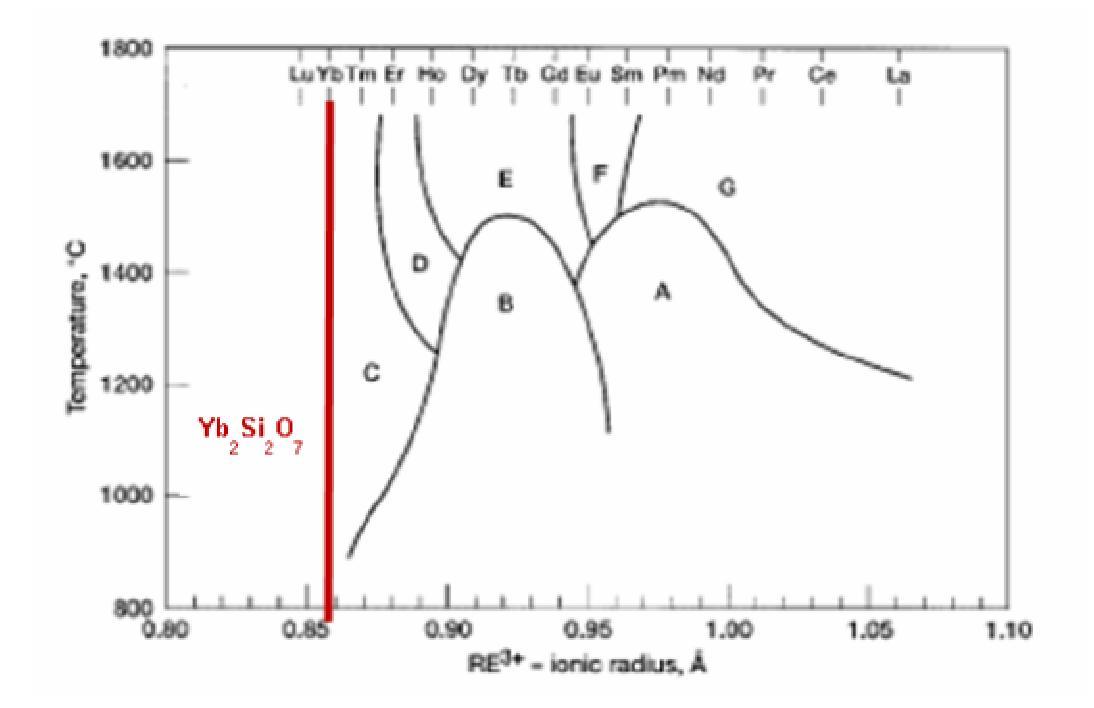
Figure 3: Rare earth disilicate phase stability as a function of ionic radius⁴

In Figure 3, Felsche has documented rare earth disilicate phase stability with respect to the ionic radius of the rare earth element, over the temperature range of 800°C to 1800°C. The rare earth elements are listed on the horizontal axis at the top of the chart at locations corresponding to their ionic radii. The lines separating the phase regions indicate where a phase change occurs. (Phases shown in Figure 3: A: tetragonal; B and F: trigonal; C and D: monoclinic; E: orthorhombic; G: pseudo-orthorhombic.) Both Lusilicates and Yb-silicates exhibit monoclinic phase stability up to 1600°C. Due to the significantly higher cost of Lu, Yb was investigated more closely.

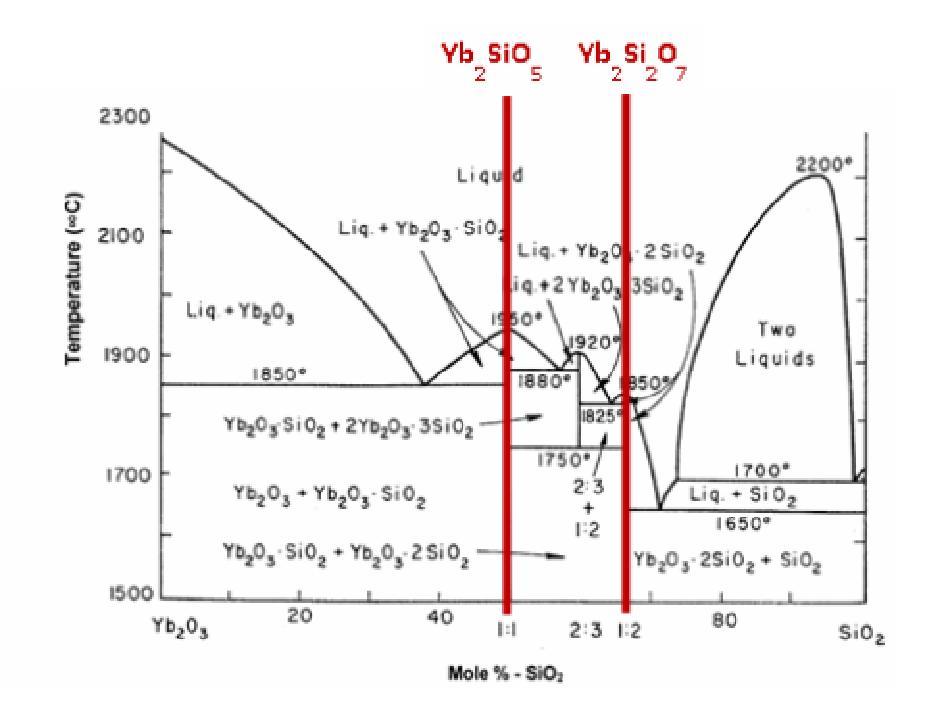
Figure 4: Yb_2O_3 - SiO_2 phase diagram with monosilicate and disilicate line compounds indicated⁵

As seen in the Yb₂O₃-SiO₂ phase diagram (Figure 4), Yb₂SiO₅ and Yb₂Si₂O₇ are both line compounds, showing phase stability up to 1950°C (Yb₂SiO₅) and 1850°C (Yb₂Si₂O₇). Rare earth monosilicates (RE₂SiO₅) exhibit greater chemical stability with H₂O than rare earth disilicates (RE₂Si₂O₇). In a water vapor environment, the SiO₂ in the disilicate will volatilize and produce Si(OH)₄, potentially leading to the eventual transformation of the disilicate to a monosilicate. The monosilicate is more chemically stable, so SiO₂ within the EBC is less likely to volatilize.

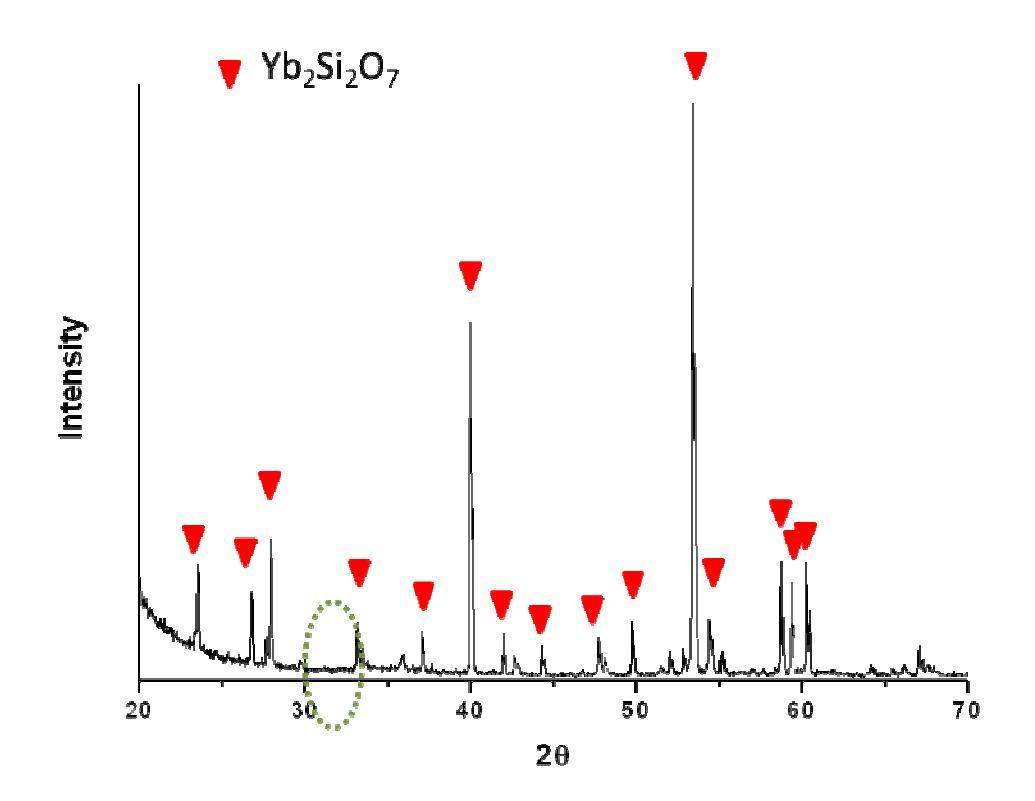
Figure 5: Representative XRD pattern of EBC pellet with acceptable phase purity for testing

The environmental barrier coatings used in this study were made via reaction sintering. A stoichiometric molar ratio of Yb₂O₃(99.99% purity, MTI Corporation, Richmond, CA) and SiO₂ (reagent grade, Supelco Analytical, Bellefonte, PA) (Yb₂O₃:SiO₂ = 1:2) powders wereball milled in ethanol for 48 hours. The resulting slurry was then dried on a hot plate while continuously stirred. Using a hydraulic press, the powder was pressed into 0.5-inch diameter pellets at a pressure of 2500 lbs. Using cold isostatic pressing (CIP), the green body was subjected to a pressure of 205 MPa. The resulting pellet was then sintered in a platinum crucible at 1650°C for 24 hours, resulting in at least 97% theoretical density ($\rho = 6.13$ g/cm³), as measured using Archimedes' principle. X-ray diffraction (XRD) was performed on each pellet to confirmat least 90% estimated phase purity, using an X-ray diffractometer (XDS 2000, Scintag Inc., Cupertino, CA). A representative XRD scan is shown in Figure 5, with primary Yb₂Si₂O₇ peaks indicated by triangles, and a dashed-line circle around the region where the primary Yb₂SiO₅ peaks would appear if the monosilicate were present. Unmarked peaks include minor Yb₂Si₂O₇ peaks, unreacted SiO₂, and XRD background.

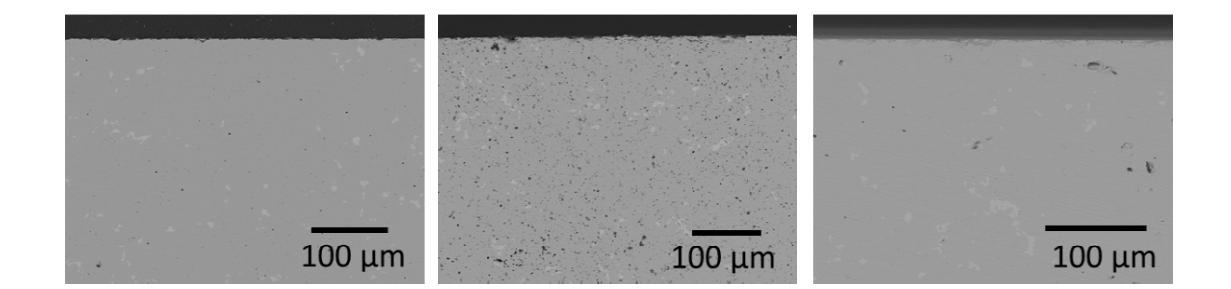
Figure 6: Cross-sectional BSE images of $Yb_2Si_2O_7$ pellets: (1-r) as-sintered, after 24h in air environment, after 168h in air environment

Figure 6 shows a cross-sectional BSE image of an as-sintered Yb₂Si₂O₇ EBC pellet adjacent to cross-sectional BSE images of Yb₂Si₂O₇ pellets that have been exposed to a 1300°C air environment for 24 and 168 hours, respectively. Over time, little change in microstructure was observed.

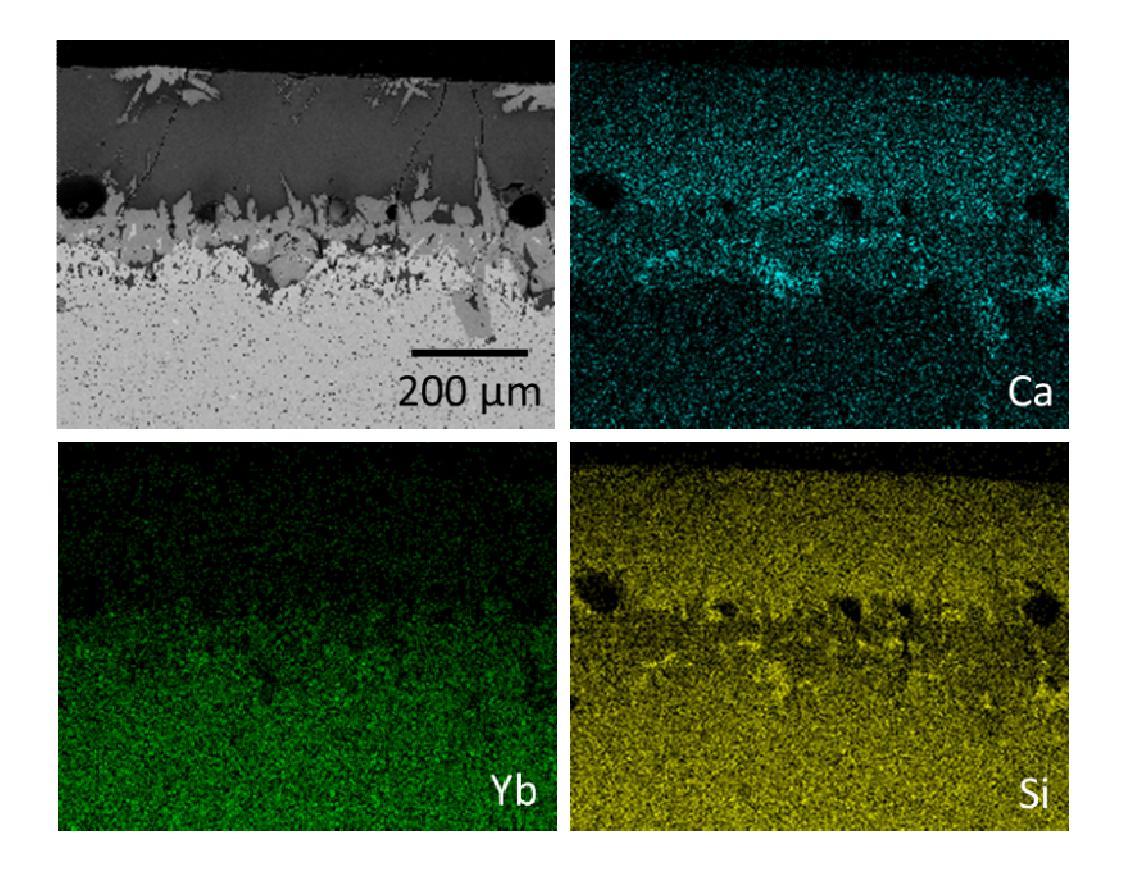
Figure 7: (clockwise from upper left) BSE image, and EDS maps of Ca, Si, and Yb in specimen exposed to air environment at 1300°C for 24 hours

In Figures 7 through 10, a BSE image of a sample cross-section from each air environment test is displayed alongside EDS maps of calcium, ytterbium, and silicon. Due to EDS peak overlap of magnesium and aluminum with ytterbium and silicon, the presence of calcium is the strongest qualitative indicator of CMAS penetration into the EBC. Many of the ytterbium maps indicate the presence of Yb in the reaction layer, showing that the EBC is in fact reacting with the CMAS, and the presence of CMAS in the EBC is not limited to grain boundary penetration. In the BSE image in Figure 7, the darker gray region in the upper half of the image is primarily residual CMAS sitting on top of the EBC, and the lighter-colored grains of reaction product can be seen not only in the reaction layer, but scattered in the CMAS layer as well. As time progresses, the EBC and amorphous CMAS continue to react, forming a crystalline reaction layer that helps to prevent bulk CMAS penetration into EBC grain boundaries.

As can be seen in Figures 7 through 11 and 14 through 18, a thermochemical reaction occurs in both air environments and water vapor environments at 1300°C. In this study, evaluation of the reaction zone is limited to the cross-section of the area where each sample was sectioned after testing. In the water vapor environment, it appears that an apatite-like reaction phase forms, as evidenced by the needle-like microstructure visible in Figure 16. TEM results indicate that this reaction phase is composed of Yb-Ca-Si-Fe, a compound of which little is known.

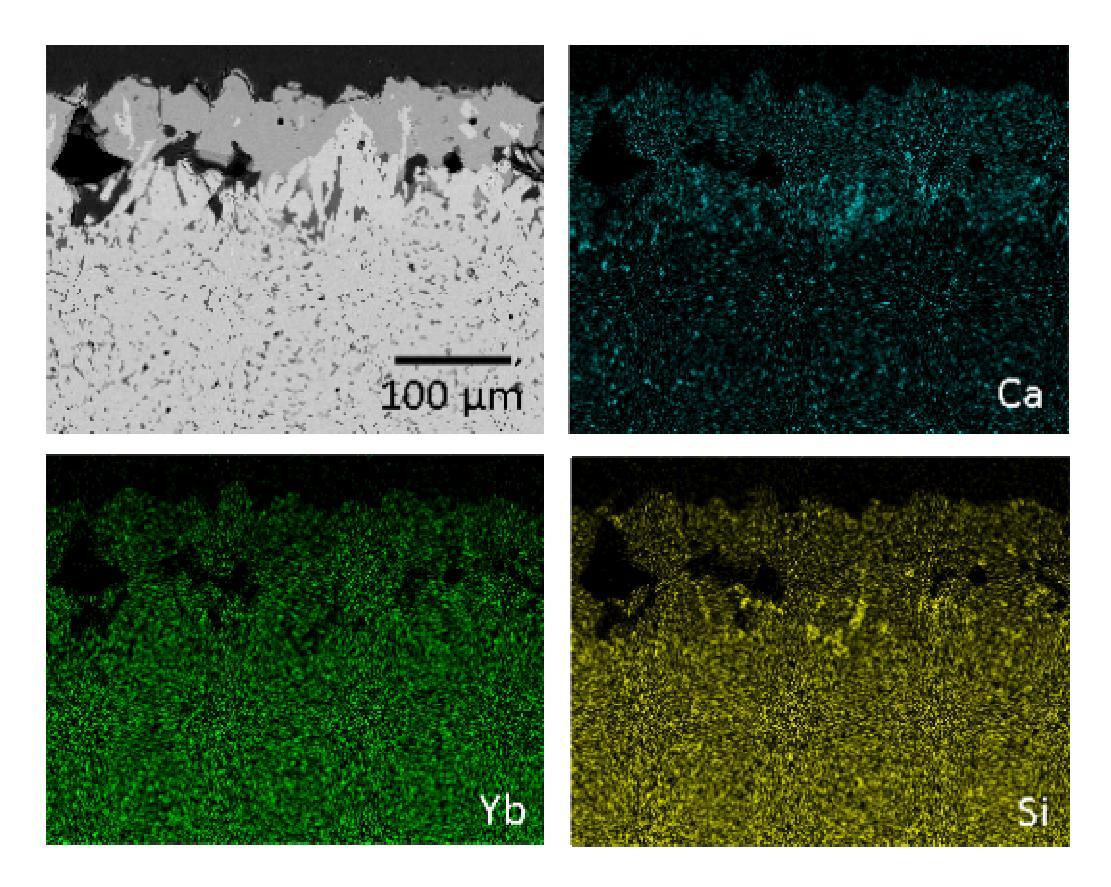
Figure 8: (clockwise from upper left) BSE image, and EDS maps of Ca, Si, and Yb in specimen exposed to air environment at 1300°C for 72 hours

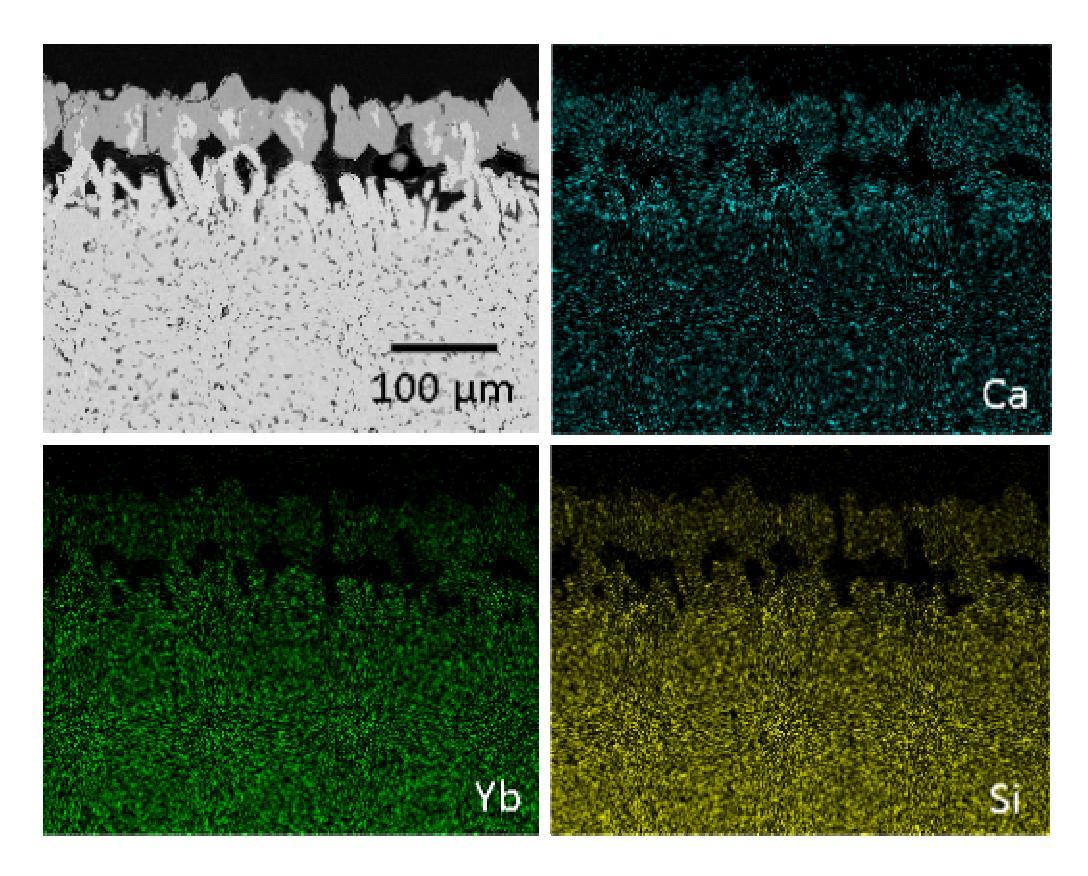
Figure 9: (clockwise from upper left) BSE image, and EDS maps of Ca, Si, and Yb in specimen exposed to air environment at 1300°C for 120 hours

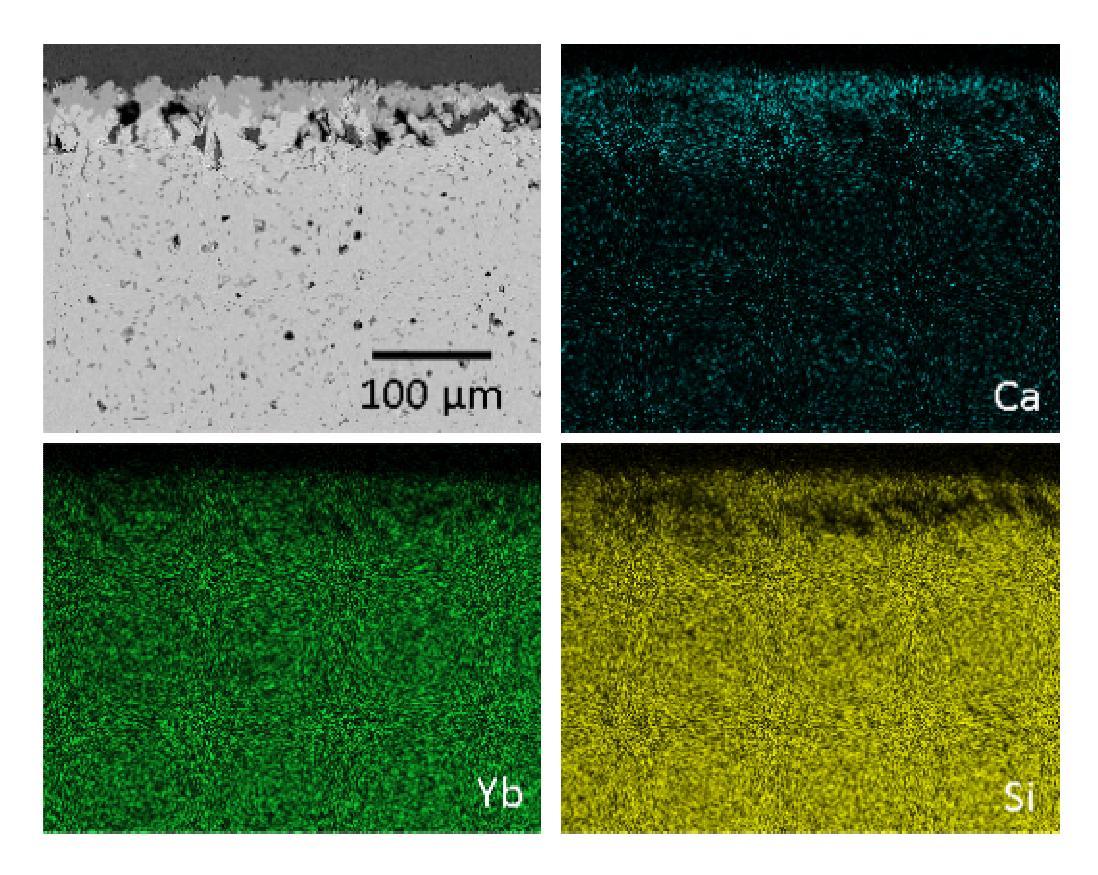
Figure 10: (clockwise from upper left) BSE image, and EDS maps of Ca, Si, and Yb in specimen exposed to air environment at 1300°C for 168 hours

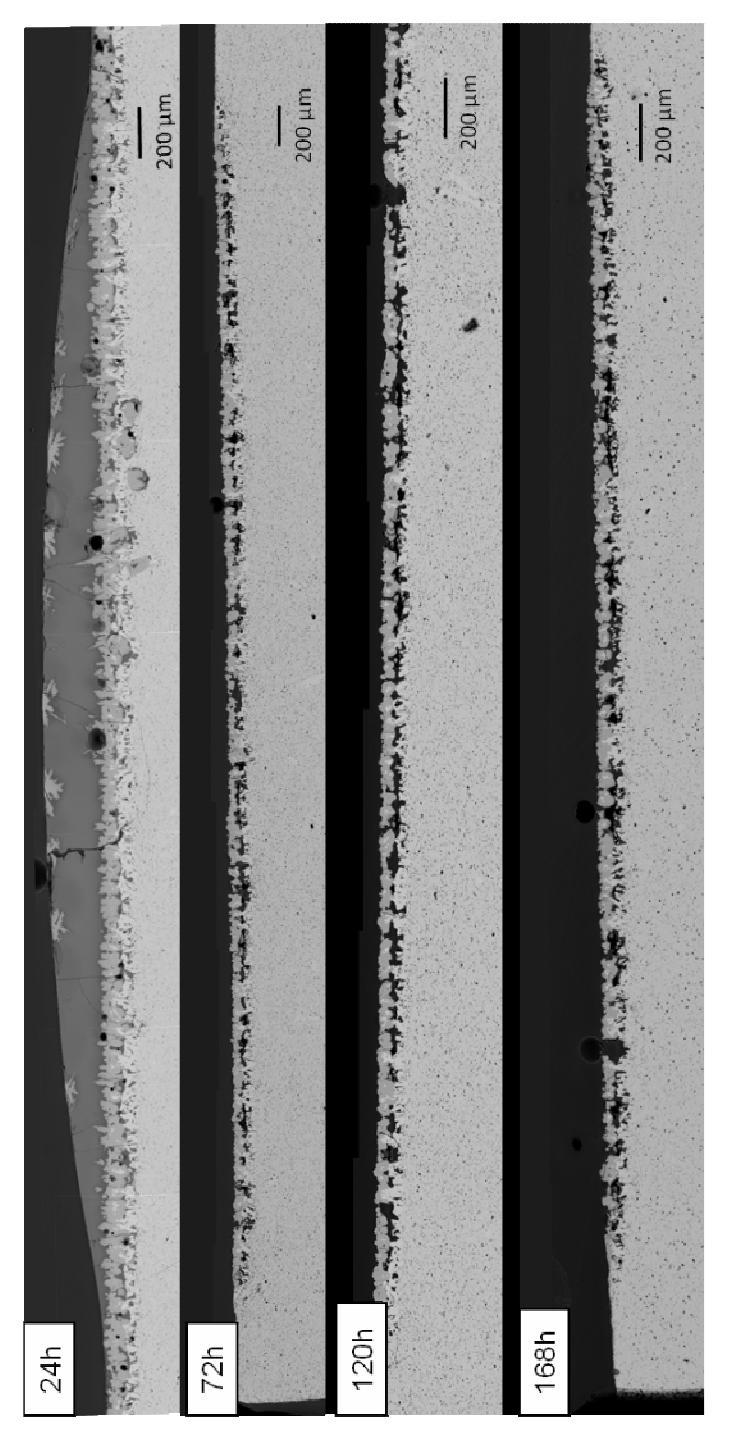
Figure 11: BSE images of EBC cross-sections of reaction zones after 24h, 72h, 120h, and 168h at 1300°C in airenvironment

Figure 11 shows a time-based progression of BSE EBC cross-sectional images following air environment testing in the presence of CMAS. These cross-sectional images offer a more comprehensive view of the extent of the EBC-CMAS reaction. The visual clarity of the resulting reaction microstructure is not as great as after testing in water vapor environment, shown in Section 4.2.

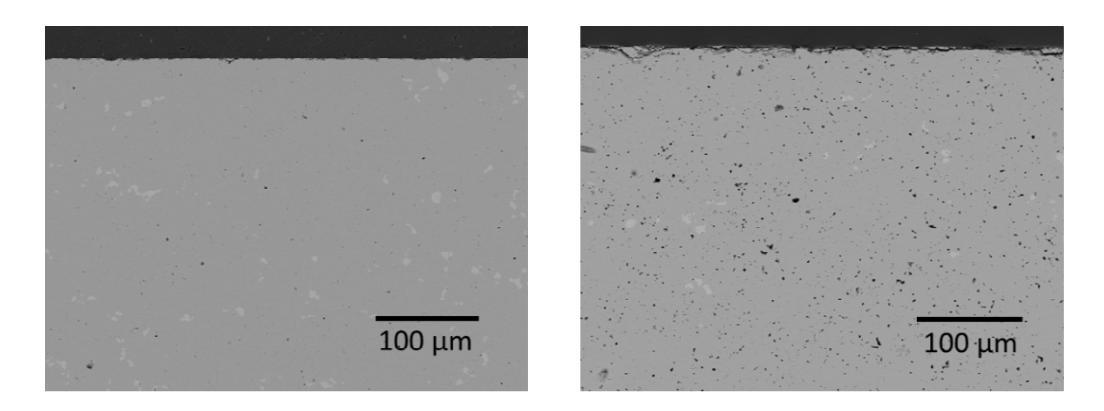
Figure 12: Cross-sectional BSE images of $Yb_2Si_2O_7$ pellets as-sintered (left) and after 24h in water vapor environment (right)

Figure 12 shows a cross-sectional BSE image of an as-sintered Yb₂Si₂O₇ EBC pellet adjacent to a cross-sectional BSE image of an Yb₂Si₂O₇ pellet that has been exposed to a 1300°C air environment for 24 hours. Figure 13 shows the cross-sectional BSE image of an as-sintered Yb₂Si₂O₇ EBC pellet next to the cross-sectional BSE image of an Yb₂Si₂O₇ pellet that has been exposed to a 1300°C air environment for 168 hours. In both cases, little change in microstructure was observed over time.

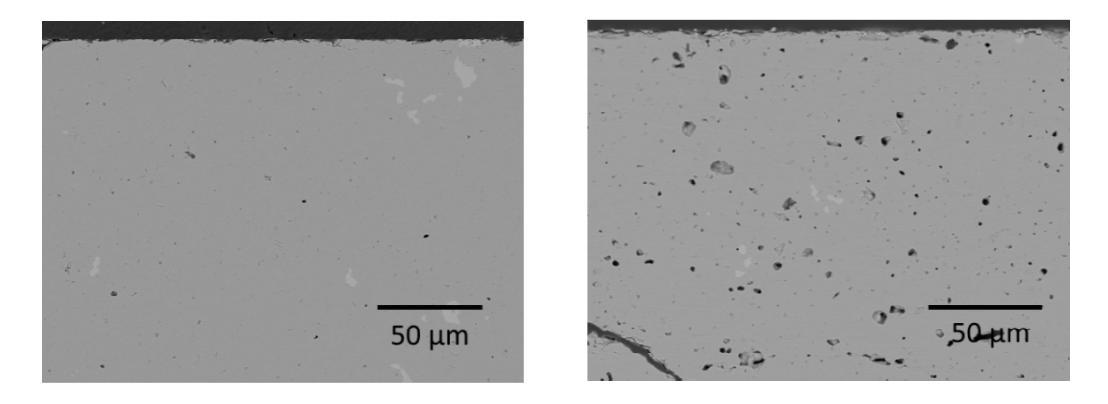
Figure 13: Cross-sectional BSE images of $Yb_2Si_2O_7$ pellets as-sintered (left) and after 168h in water vapor environment (right)

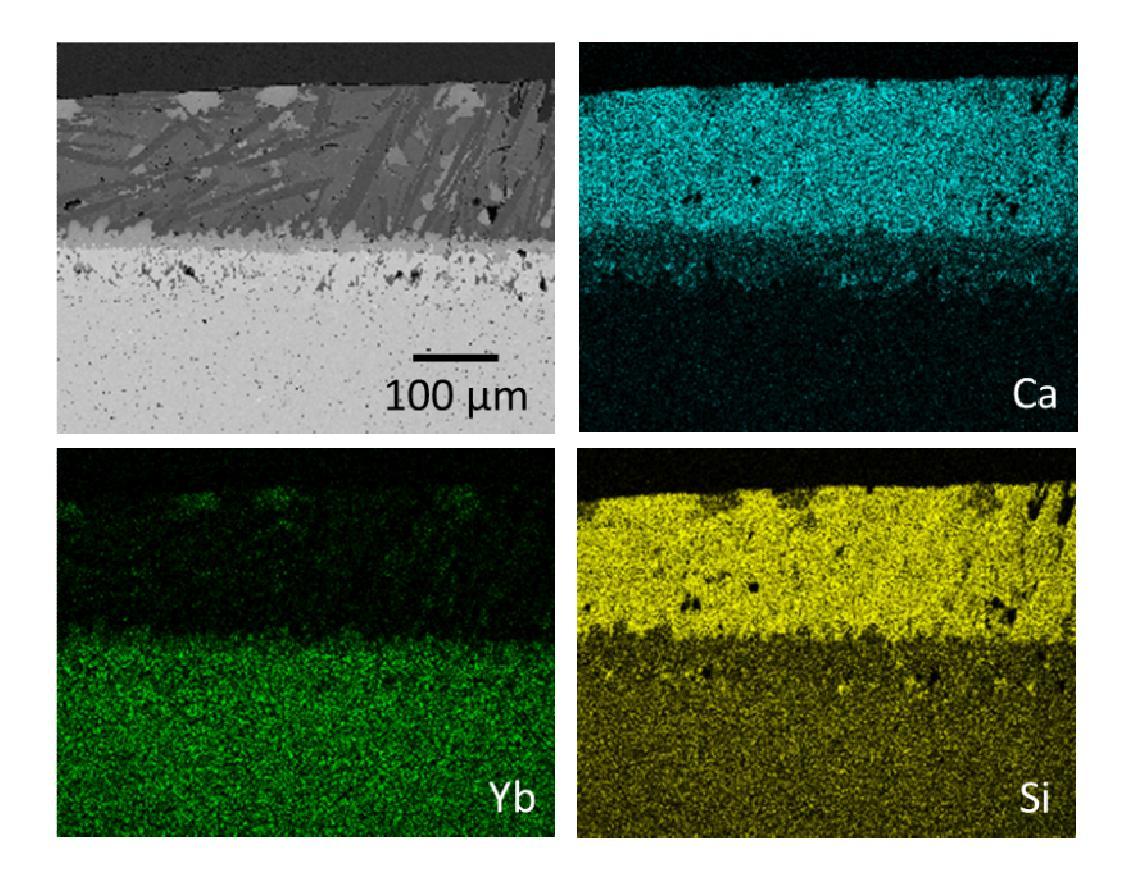
Figure 14: (clockwise from upper left) BSE image, and EDS maps of Ca, Si, and Yb in specimen exposed to water vapor environment at 1300°C for 24 hours

In Figures 14 through 17, a BSE image of a sample cross-section from each water vapor environment test is displayed alongside EDS maps of calcium, ytterbium, and silicon. As above, the presence of calcium is the strongest qualitative indicator of CMAS penetration into the EBC. In the BSE images in Figures 14 through 16, the darker gray region in the upper half of the image is primarily residual CMAS sitting on top of the EBC, where the microstructure of the reaction product can be clearly seen. As time progresses, the EBC and amorphous CMAS continue to react, forming a crystalline reaction layer that helps to prevent bulk CMAS penetration into EBC grain boundaries. Also, the CMAS and water vapor continue to react as time progresses, creating complex reaction products which are discussed further in Chapter 5.

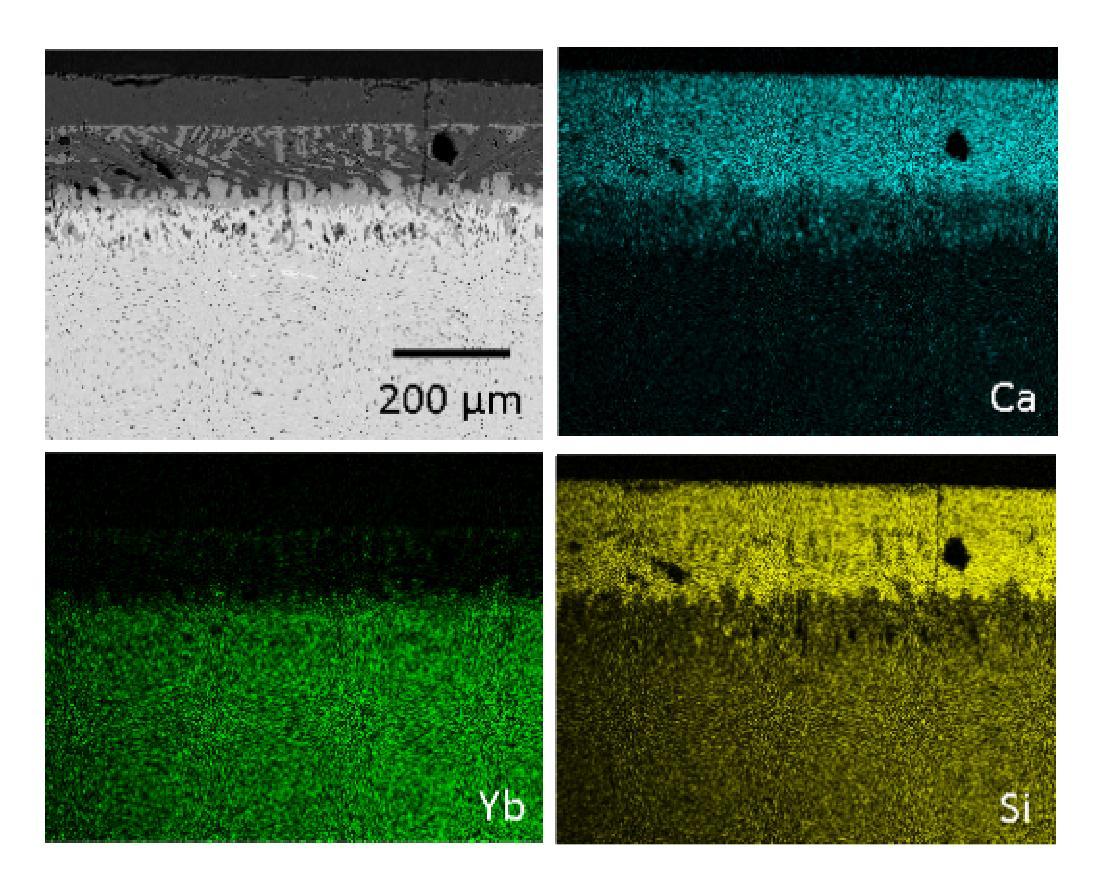
Figure 15: (clockwise from upper left) BSE image, and EDS maps of Ca, Si, and Yb of specimen exposed to water vapor environment at 1300°C for 72 hours

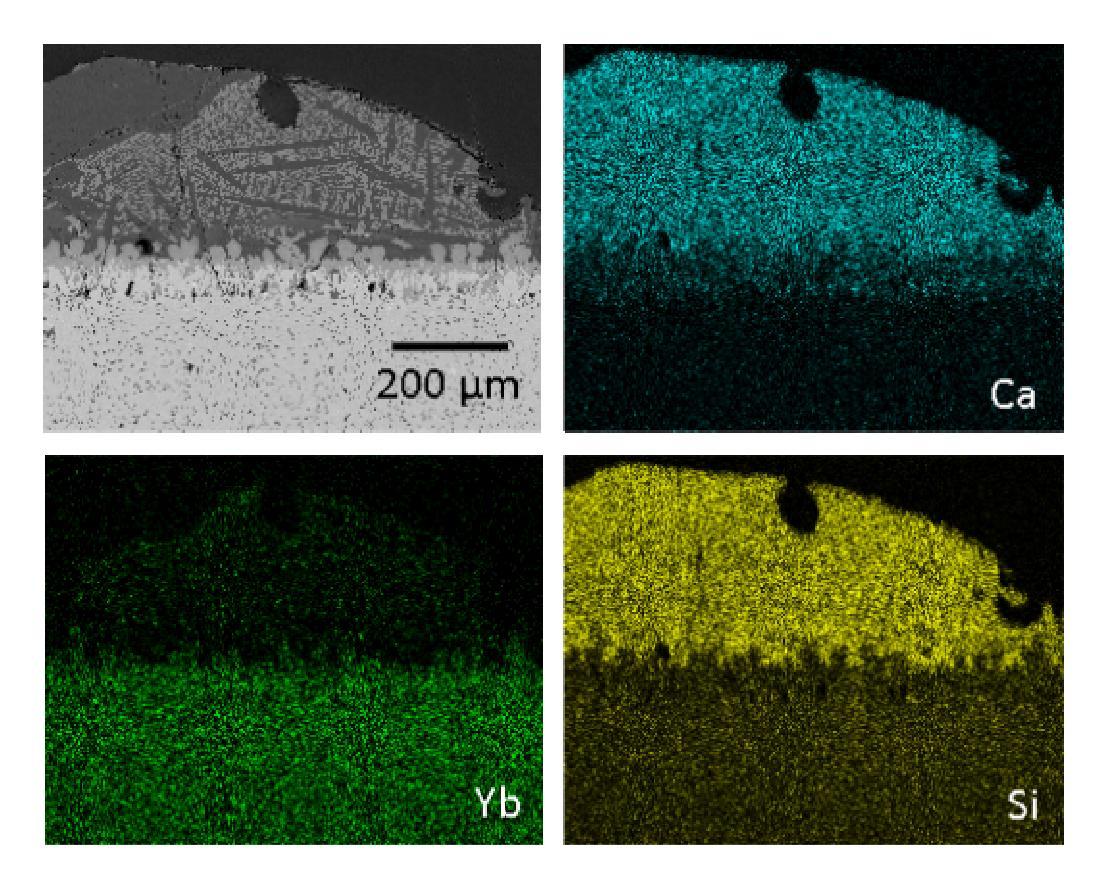
Figure 16: (clockwise from upper left) BSE image, and EDS maps of Ca, Si, and Yb of specimen exposed to water vapor environment at 1300°C for 120 hours

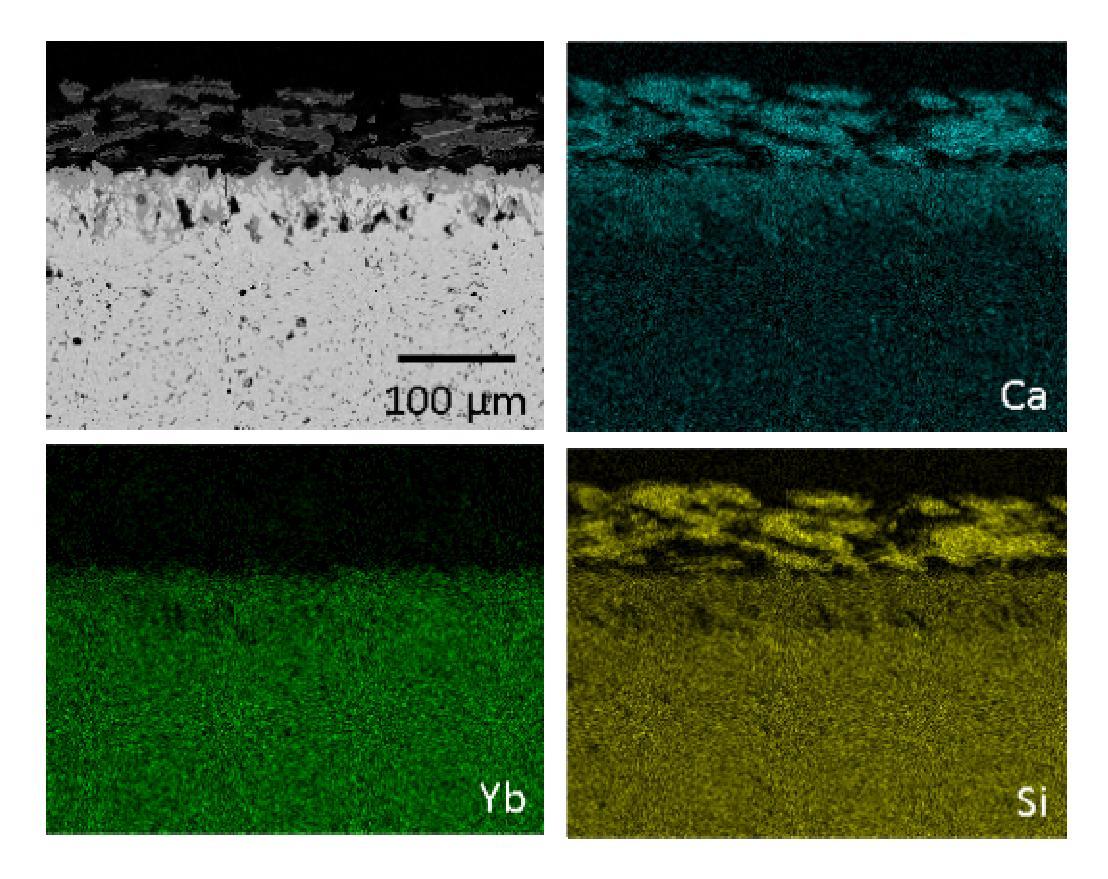
Figure 17: (clockwise from upper left) BSE image, and EDS maps of Ca, Si, and Yb of specimen exposed to water vapor environment at 1300°C for 168 hours

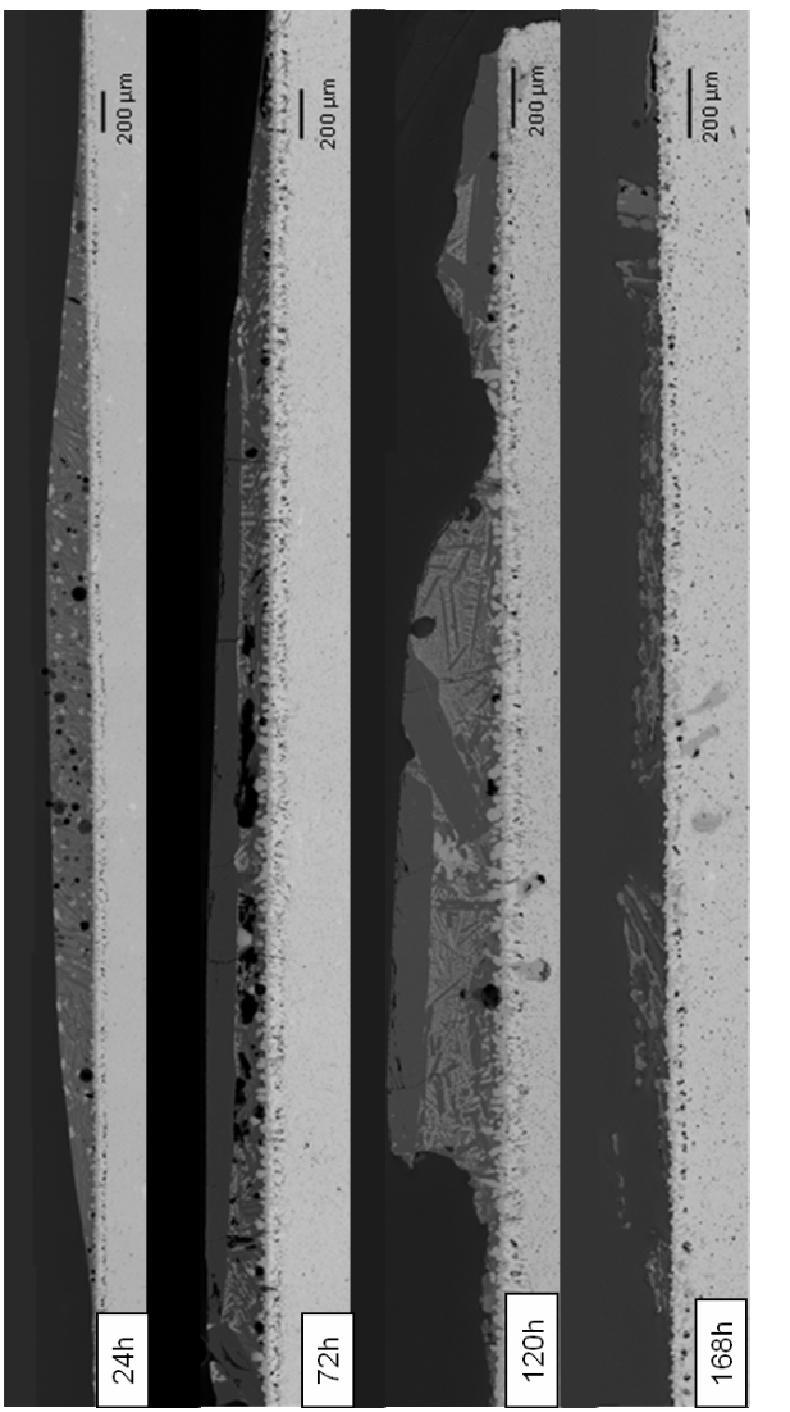
Figure 18: BSE images of EBC cross-sections of reaction zones after 24h, 72h, 120h, and 168h at 1300°C inwater vapor environment

Figure 18 shows a sequential progression of EBC cross-sections following water vapor environment testing in the presence of CMAS. These cross-sectional images offer a more comprehensive view of the extent of the EBC-CMAS reaction, in addition to the character of the resulting reaction microstructure.

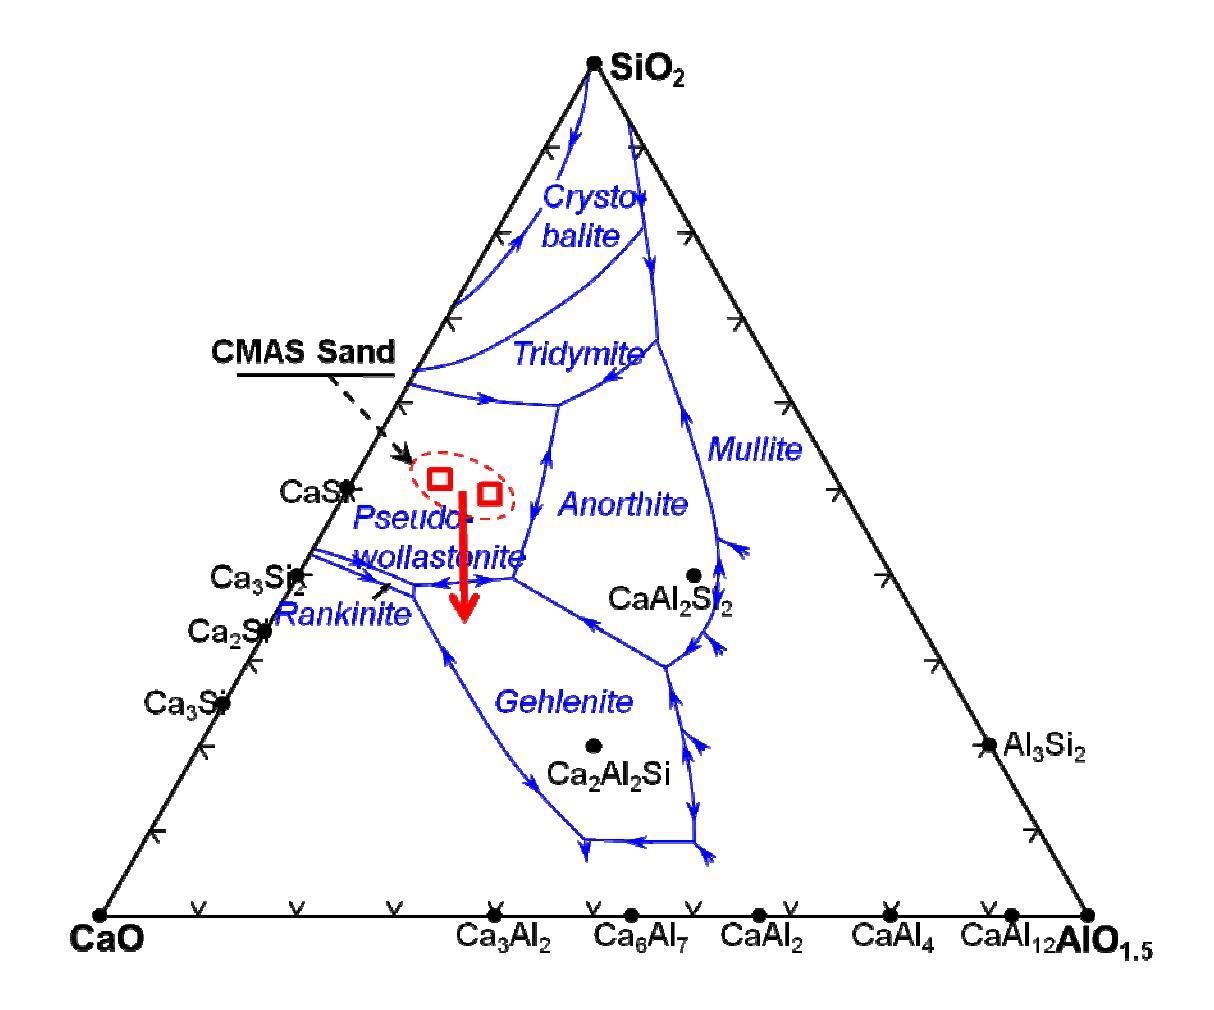
Figure 19: Ternary phase diagram for primary components of CMAS, with common CMAS composition region indicated by dashed red oval⁹

Another theory as to what is happening to the CMAS-coated EBCs in a water vapor environmentis that as the SiO₂ in the CMAS preferentially volatilizes, it shifts the CMAS composition from amorphous Pseudo-wollastonite to crystalline Gehlenite. In the ternary phase diagram of major components of CMAS shown in Figure 19, a dashed red oval shows the region of common CMAS compositions from the field. The phase shift due to depletion of SiO₂ in this CMAS composition is indicated by a red arrow. Pseudo-wollastonite is difficult to crystallize; conversely, Gehlenite crystallizes readily. Amorphous CMAS more easily penetrates the EBC via grain boundary attack. However, with this shift to a crystalline phase, the now-crystalline CMAS does not pose a significant threat to the integrity of the EBC, as it crystallizes on the surface of the EBC and does not penetrate the EBC along the grain boundaries.

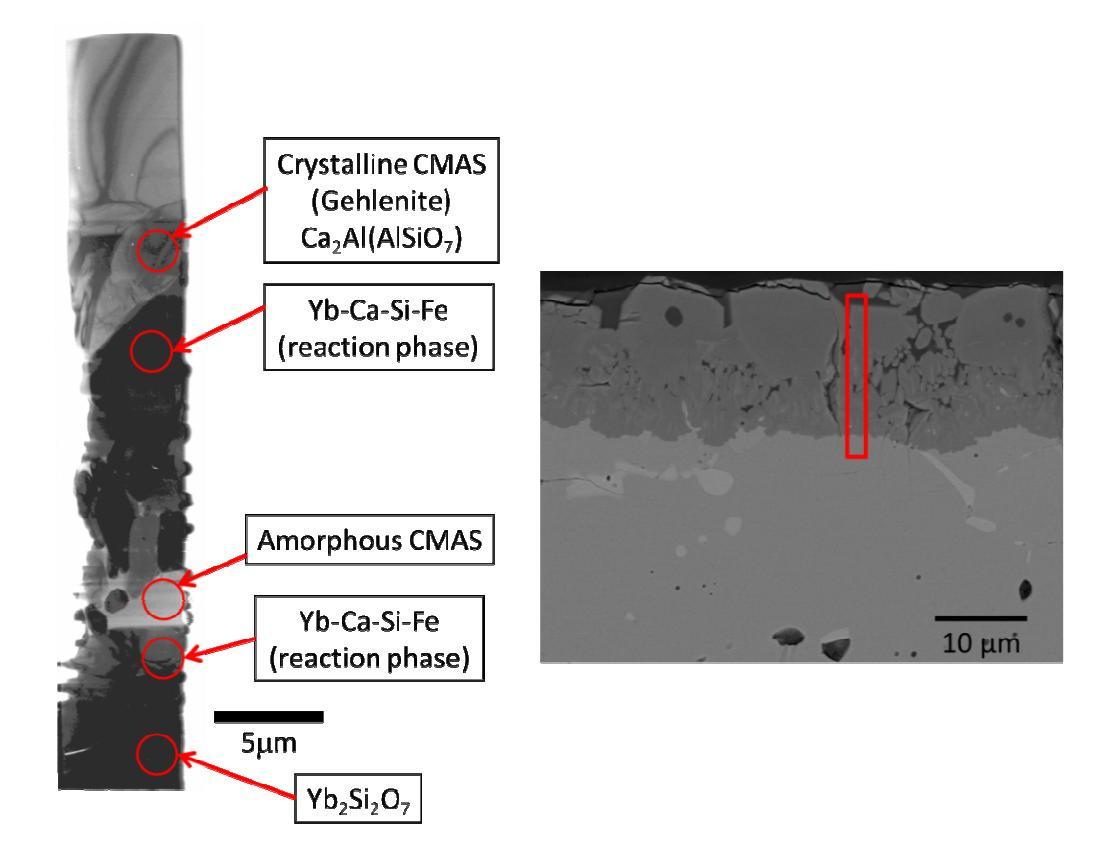
Figure 20: TEM results from $Yb_2Si_2O_7$ sample exposed to water vapor environment for 24 hours at $1250^\circ C$

TEM results from a related study on the interaction of $Yb_2Si_2O_7$ and CMAS in a water vapor environment at 1250°C can be found in Figures 20 and 21 in the Appendix.

TEM results (Figures 20 and 21) from a 24 hour water vapor environment test at 1250°C show the presence of crystalline CMAS near the surface of the EBC-CMAS sample. There is an Yb-Ca-Si-Fe reaction phase below that, situated amid amorphous CMAS glass. At the base of the evaluated region is the Yb₂Si₂O₇ EBC material. Further studies involving this unusual Yb-Ca-Si-Fe compound is necessary in order to gain a better understanding of the reaction phase and its properties.

Figure 20 shows TEM results from a 24 hour water vapor environment test on hot-pressed $Yb_2Si_2O_7$ with 5 mg/cm² of CMAS evenly distributed across its top surface. The region from where the TEM foil was extracted is indicated by the rectangle on the SEM image on the right side of the figure.Figure 21 shows the indexed TEM pattern from the crystalline CMAS region in Figure 20. This pattern indicates that the crystalline CMAS phase is Gehlenite. (TEM work courtesy of Andy Gledhill and Julie Drexler.)

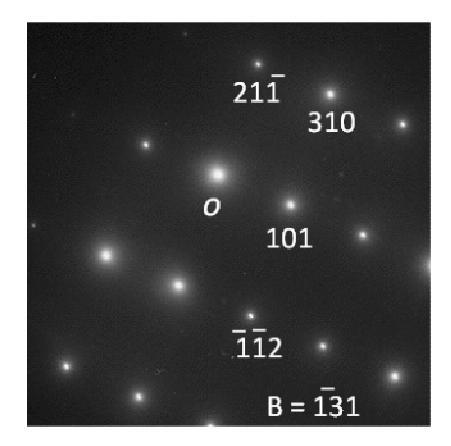
Figure 21: Indexed TEM pattern from crystallized CMAS region indicating Gehlenite
